Head-Neck Taper Corrosion in Total Hip Arthroplasty: Catastrophic Cases Report and Review

Molfetta L^{1*}, Florian A², Palermo A³, Capozzi M⁴ and Formica M³

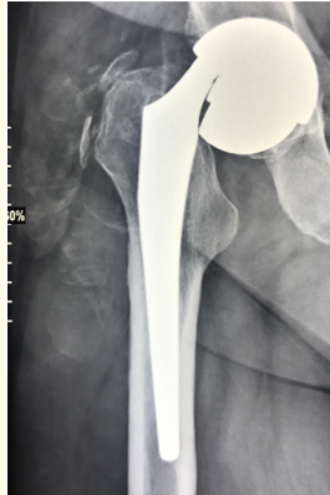
After 11 years in absence of distress or malalignment, a severe and acute hip pain appeared. Rx showed disassembling of head-neck junction of the stem that was worn out and deformed (Figure 1). two modular components was confirmed.

Figure 1: Disassembly of head-neck due to corrosion of V40 femoral neck.

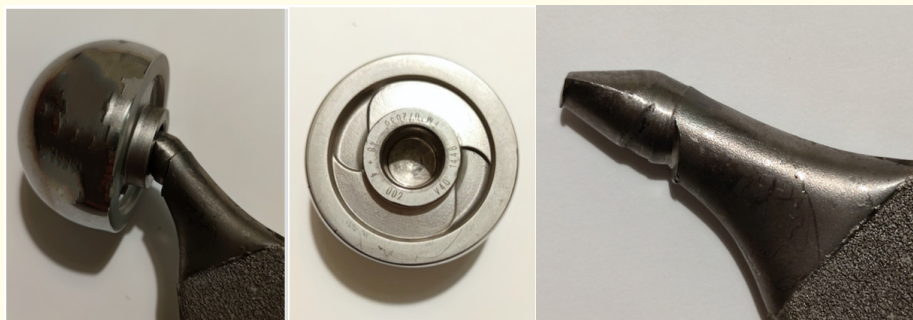
There were severe signs of wear and tear especially on the lateral portion, without significant involvement of the CoCr female portion (Figure 2). There was an intense periarticular metallosis, secondary to the metal debris from the femoral stem’s neck (V40 Taper). Histologically wear debris disease was confirmed (Figure 3). Blood levels of Cr and Co were normal without any clinical sign. The patient, moreover, had not reported any general disorders related to an increase of the two ions.

Figure 2: Fretting corrosion of the neck; note the damage at the base of the femoral neck, medially, caused by impact of the female portion of the head.

A non-cemented Tracer cup and Exacta (Premedical, Milan) stem was implanted, restoring morphometric parameters of the hip. Post-operative course was regular with good clinical recover after rehabilitation in terms of muscle tone, proprioceptive, movements and gait scheme.

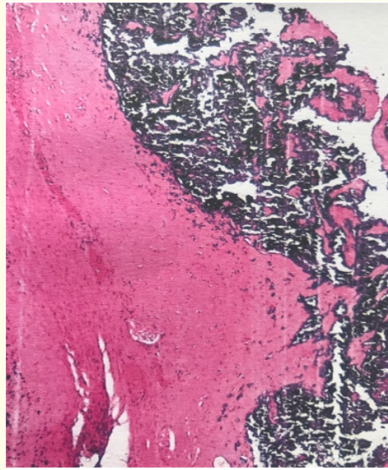
Figure 3: Histological evidence of metallosis.

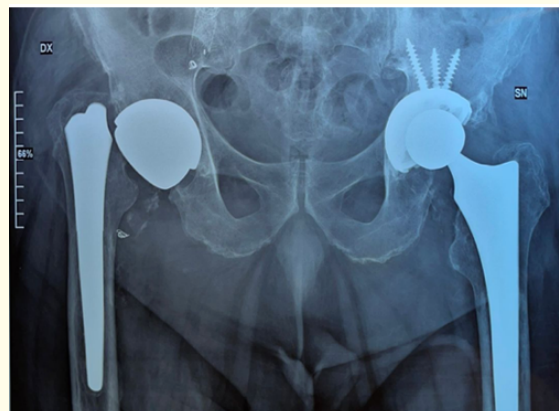
After 14 years, in orthostasis, the patient felt a clatter from right hip with subsequent failure and fall to the ground. Rx showed the break of prosthetic neck while the stem was correctly integrated into the bone, as the acetabular cup (Figure 4).

Figure 4: Second case of V40 disassembly.

The revision surgery consisted in re-implantation of Wagner long stem with bone cerclages in order to stabilize the bone window. For the cup, that was intact without internal abrasion, a PE insert was used. The neck corrosion was located 1 cm below the inferior hedge of the cono-morse of the lower diameter (Figure 5). The break-section was divided in two parts; the lateral one, curved "crescent-like", opaque and almost horizontal due to prolonged contact with female portion of the large metallic prosthetic head; the medial part was wedge, "cotyledon-like", vertical and more polished.

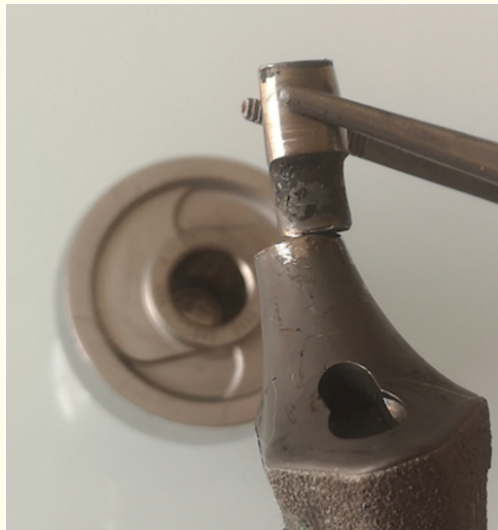
Figure 5: The break-section divided in two parts: the lateral one, curved "crescent-like", horizontal; the medial part was wedge, "cotyledon-like", vertical.

These aspects are secondary to an event occurred in two different moments: the first one, slow, lasting a few years and the second one, acute with sudden structural failure. Further demonstration was the diffuse metallosis with stack of the debris at calcar. More precisely, the accumulation was into the crook of female portion of the cono-morse, where the fractured part of the prosthetic neck was located.
