In this case, the management of an incomplete vertical root fracture of a right lower second molar of sixty years old female patient, the finalization of the treatment and follow-up were presented as an alternative clinical approach versus extracting the tooth.

*Citation:* M Omer Gorduysus and Burcu A Pektas. "Management of an Incomplete Vertical Root Fracture: An Alternative Clinical Approach and Treatment Finalisation Concept for a Case" *EC Dental Science* 1.4 (2015): 180-185.

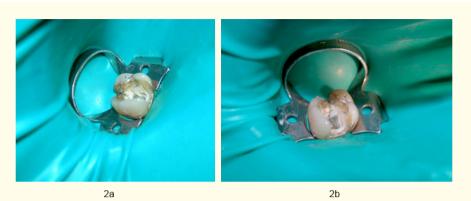
A 60 year-old female patient presented with "intermittent, sharp pain". An intraoral exam revealed that a large failing amalgam with leaking margins on the right lower second molar. The tooth had a very painful response to percussion. No soft tissue changes recorded. The radiograph of the tooth (Figure 1) exhibited a widened periodontal ligament space but no periradicular radioluceny. The medical and dental histories of the patient were unremarkable. The bite test was increasing the discomfort. Amalgam filling was removed and seen a fracture line prolonged from distal to mesial also alongside of the distal axial wall and also towards to the floor of the pulp chamber partially (Figure 2a-b, Figure 3) conventional root canal therapy was completed with rotary system (ProTaper, Dentsply-Maillefer, Switzerland) and RC Prep (Premier, Norristown, PA, USA) as a lubricant. Copious irrigation with 2% sodium hypochlorite solution was employed throughout the procedure. Obturation of the root canals was performed using Protaper's gutta-percha (For mesial canals F2 and for distal canal F3) and AH 26 (Dentsply Maillefer) root canal sealer was used (Figure 4) Later the tooth was submitted under the operation microscope to pursuit the incomplete vertical fracture line with Mueller burs and ultrasonic tips until the line disappears as much as possible (Figure 5a-b). After that the tooth was restored with glass ionomer following the bonding of two sides of the remaining craze line at the floor of the pulp chamber with an adhesive which was left over in obligation to the tooth structure and the critical extension of the vertical crack line (Figure 6) and crowned to finalize the case without any post for not to increase the stress over the tooth (Figure 7).

Figure1: Initial (preoperative) radiograph.
