Mispositioned Pigtail Catheters in Patients with COVID-19 Pneumonia

Keywords: Pigtail Catheters; COVID-19; Pneumonia

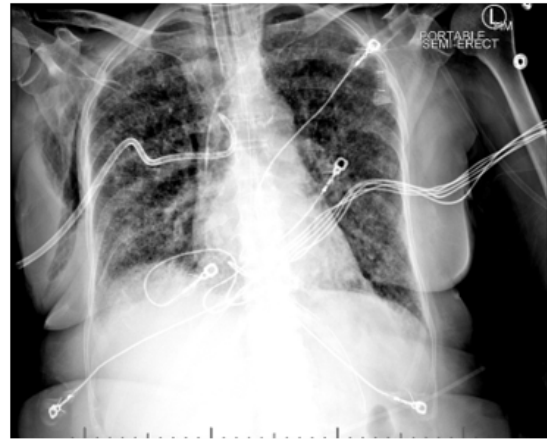
hemodynamic instability of the patient. A 14 french pigtail catheter was placed via Seldinger technique in the 3rd intercostal space mid clavicular line emergently. Procedure was uneventful with no reported difficulties during insertion of the guidewire or the dilator. Following the procedure there was improvement in oxygen saturation and hemodynamic instability. Post procedure x-ray (Figure 1) showed small apical pneumothorax.

Figure 1 (Case 1): X-ray of chest post procedure, showing pigtail in the right main bronchus.

A large bore (32 F) surgical chest tube was placed in the right thoracic cavity and pigtail drain was removed. Her respiratory condition remained unchanged with the continuous leak through the surgical chest tube over the next two weeks. Endoscopic or surgical repair was not feasible due to poor respiratory status. Unfortunately, her clinical condition continued to worsen due to multiorgan failure and family decided to withdraw care.

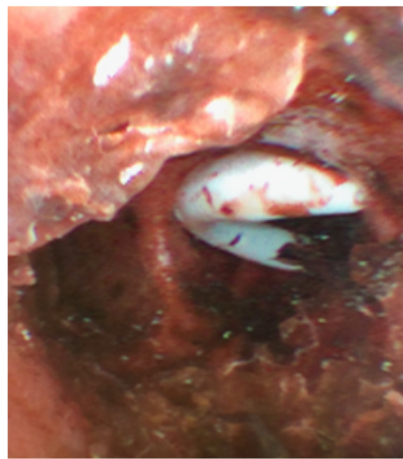
However, shortly after, continuous leak was observed in the chest tube chamber. Bedside bronchoscopy detected the tip of the catheter in the right main bronchus (Figure 2). A bronchoalveolar lavage later revealed *Cryptococcus neoformans* organism. Computerized tomography of the chest (Figure 3 and 4) demonstrated that the catheter crossing the lung parenchyma and extending into right main bronchus without any associated vascular injury.

Figure 2 (Case 1): The tip of the pigtail catheter in the right main stem bronchus shown via bronchoscopy.

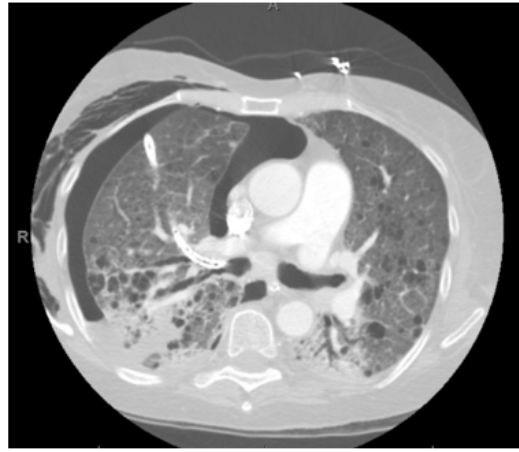
Figure 3 (Case 1): CT chest (transverse view) showing pigtail catheter in right main bronchus.

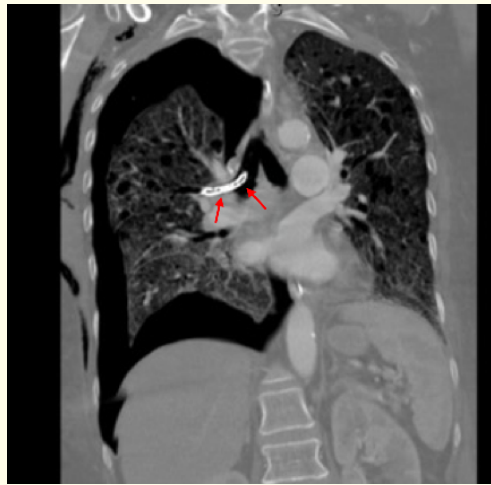
Figure 4 (Case 1): CT chest (coronal view)- red arrow showing pigtail in the right main bronchus.

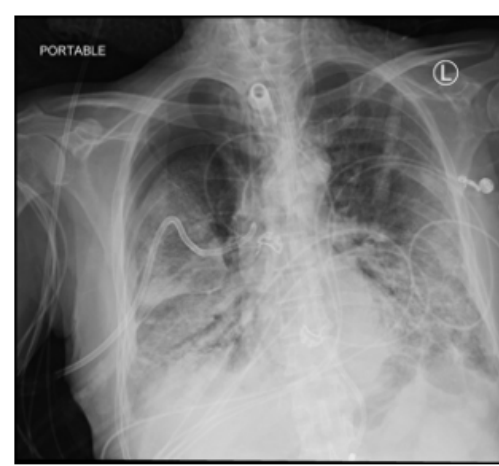
Figure 5 (Case 2): CXR post procedure, showing the pigtail catheter in the right main stem and persistent moderate pneumothorax.
