Orthograde Endodontic Retreatment of a Tooth with Four Separated Instruments in One Root Canal - A Case Report

A case with four separated instruments in the MB-canal of tooth 27 was presented. The patient is a 45 years old female and was referred to us for orthograde endodontic retreatment. The Ni-Ti fragments were located beyond the root canal's curvature. First access and visibility of three of the fragments with a dental operating microscope (OPMI Pico, Carl Zeiss) was established by some straightening of the curvature. Then three fragments were successfully removed with ultrasonic K-files (EMS). Visibility of the fourth fragment could not be achieved, as it was located deep beyond the curvature of the root canal. Bypass with small sized K-files (VDW) was attempted, but was partially successful, as full working length could not be reached. Then the root canal was shaped with manual Pro-Taper Universal (Dentsply - Maillefer) and was obturated with zink-oxide eugenol sealer (Meta Biomed) and warm gutta-percha. The case will be followed up.

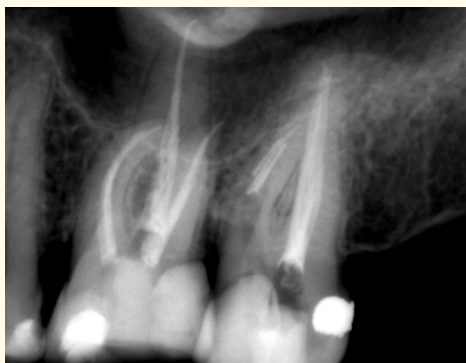
The tooth was moderately sensitive to percussion and asymptomatic to palpation. The patient could not use the tooth normally, saying it had been “tender” since the beginning of the treatment. The radiograph showed no signs of periapical pathology, but there were four broken endodontic instruments in the apical portion of the mesio-buccal root canal (Figure 1).

Figure 1: Radiograph of tooth 27 - four or more fragments in MB-canal.

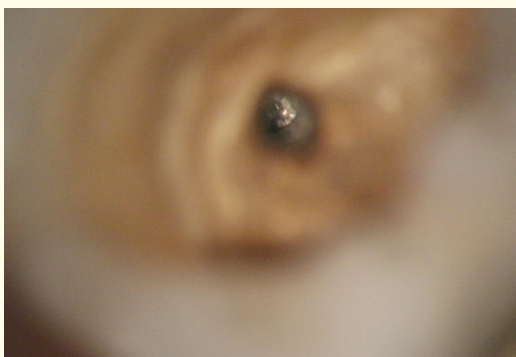
The microscopic examination (OPMI Pico, Carl Zeiss) at magnification 9x and 16x revealed one fragment only, that was barely visible at the side of the distal wall of the MB root canal (Figure 2). The rest of the fragments were hidden beyond the root canal’s curvature.

Figure 2: A micro-photograph of a fragment in MB-canal of tooth 27 (Canon EOS 100D, OPMI Pico Carl Zeiss, magnification 16x).

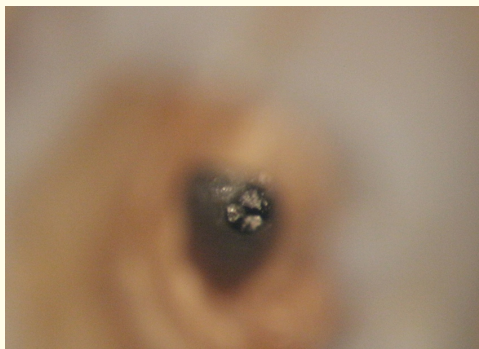
The treatment was initiated by modifying the access to the fragments using ultrasonic files ISO numbers 25 and 30 (Endosonores files, EMS, Switzerland). The files were used dry, and the operative field was kept clean by gently air-blowing away the dentin dust using a Stropko irrigator (Vista Dental, USA). After good access was established, three of the four fragments could be visualized (Figure 3).

Figure 3: A micro-photograph of 3 fragments in MB-canal of tooth 27 (Canon EOS 100D, OPMI Pico Carl Zeiss, magnification 16x).

The ultrasonic files were then used to create a staging platform and remove dentin from the distal portion of the MB-canal, as it was considered to be the safest location. After some time one of the fragments, that was located most closely to the operator, became mobile and could be removed using the ultrasonic vibration. Subsequently the other two fragments could be removed using the same instruments and technique.

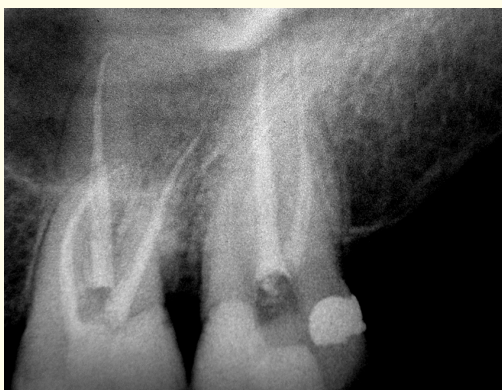
One more fragment was expected to be remaining in the root canal, but visible access to it seemed to be too risky. It was decided not to attempt to straighten the MB root canal more, so another radiograph was performed (Figure 4). It showed one more fragment, not very well visible, located at the apical end of the root canal.

Figure 4: Radiograph of tooth 27, showing a thin fragment remaining at the apical portion of MB root canal.

Bypass was attempted, using stainless steel hand K-files (VDW, Germany) with ISO numbers 08 and 10. EDTA cream was used during the bypass (MD-ChelCream, Meta Biomed, Korea). The procedure was partially successful and unfortunately full working length could not be reached. The root canal was shaped using the sequence of Pro-Taper Universal for hand use (Dentsply-Maillefer) and 5% NaOCl. The final shaping instrument was manual Pro-Taper Universal F3. The root canal was obturated with warm gutta-percha and ZOE-based sealer (ZOB-seal, Meta Biomed, Korea), Figure 5. The patient was then referred back to her dentist for follow up and final restoration.

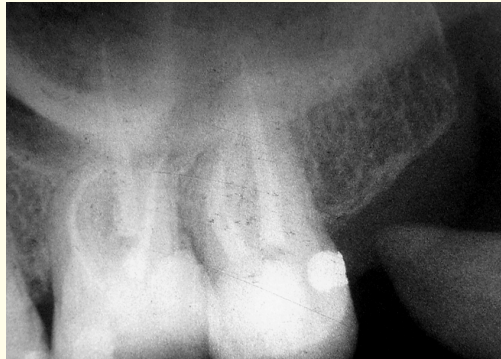
Figure 5: Radiograph of tooth 27 - MB-root canal obturated.
