The Fractographic Analysis of Ceramic Failures

Ricardo Sgura*

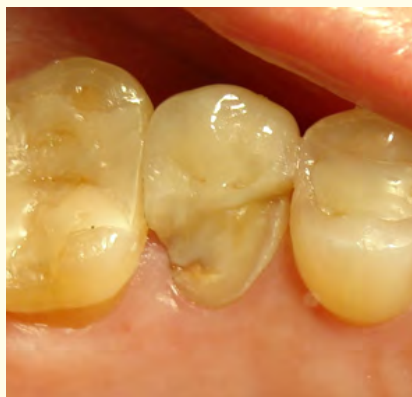
The crown was a lithium disilicate coping veneered with a feldspathic ceramic. The tooth was a premolar (15) and the prosthesis failed one year after use (Figure 1). When the patient presented herself in the dental office, two hypotheses had been raised: some mismatch in the coefficient of thermal expansion between the coping and the veneer material or some problem with the heating rate of the piece in the furnace. I studied the fractured fragment and, for our team surprise, the fracture was originated by premature contact on the internal slope of the mesial marginal ridge of the crown. The crown was rebuilt but, as a result of the fractographic study, more attention was paid to occlusal adjustments during installation. And at that time I thought how it would be important to all clinicians to know the causes of their ceramic prosthesis failures. It is a viable process.

Figure 1: Catastrophic failure of a ceramic crown after one year in use. The fracture involved the veneer porcelain and the lithium disilicate coping.

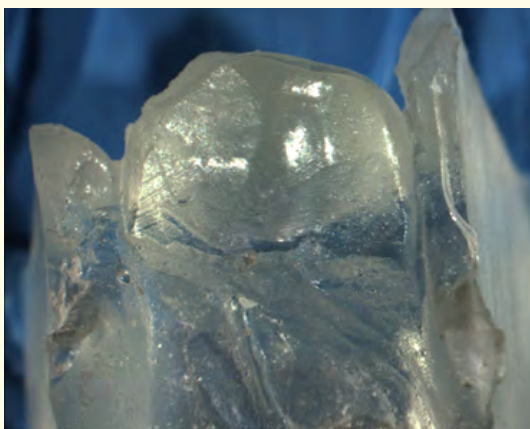
First of all, before removing the fractured crown, an impression must be conducted with addition silicone material. The impression must be poured with epoxy resin, then resulting in a positive replica of the fracture site. The necessity of a replica is justified when the absence of the other crown fragment occurs. The replica may present some voids or pores resulting from air bubbles trapped in the epoxy resin during its manipulation, but they cannot puzzle the examination of the specimen (Figure 2). Achieving the replica, which is a simple process, the clinician does his part, and may leave the subsequent investigations to the researcher (and there are a lot of ceramic researchers around the globe working with fractographic analysis).

Figure 2: A replica in epoxy resin achieved for further investigation.

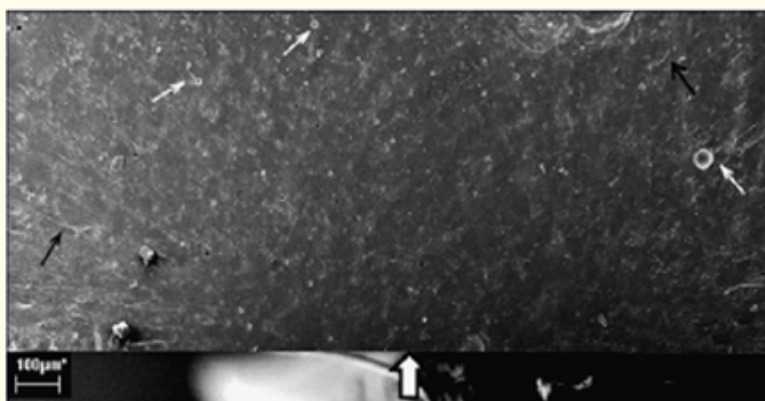
For the replica analysis, a stereomicroscope with magnification up to 45 times can be used. The stereomicroscope analysis indicates possible crack origin sites. The use of transillumination in this process is also very important. Then, based on the observations in lower magnifications, a rigorous SEM analysis must be conducted and the researcher has to follow those parameters established in academic literature (Figure 3).

Figure 3: An example of a fractographic analysis conducted based on SEM image. Thin arrows indicate the hackles formed during the fracture process occurring in the ceramic material (Sgura R., et al. *Journal of the Mechanical Behavior of Biomedical Materials*, 2012).
