# Conservative Approach for Treating Erosive Tooth Wear Patient : A Clinical Report

# **Clinical Report**

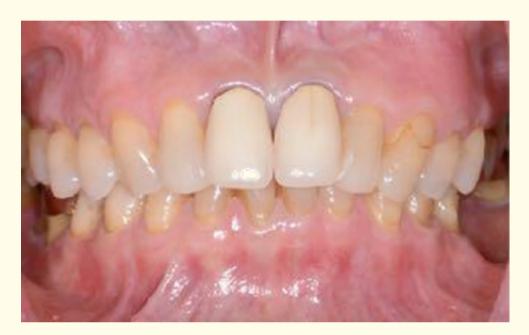
Figure 1: Pretreatment frontal view.

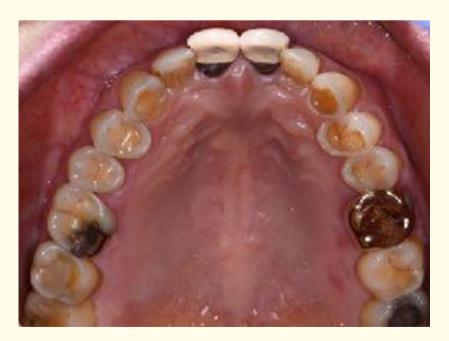
Figure 2: Pretreatment Maxillary occlusal view.

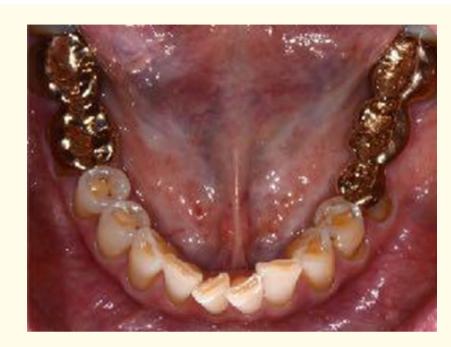
Figure 3: Pretreatment Mandibular occlusal view.

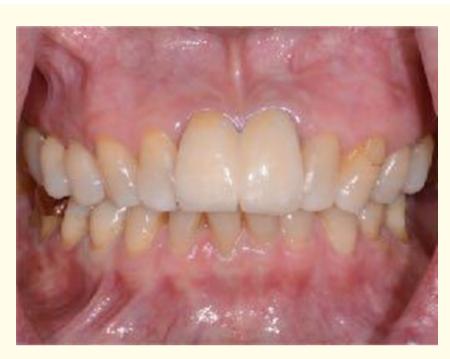
Figure 5: Frontal view of provisional restorations.

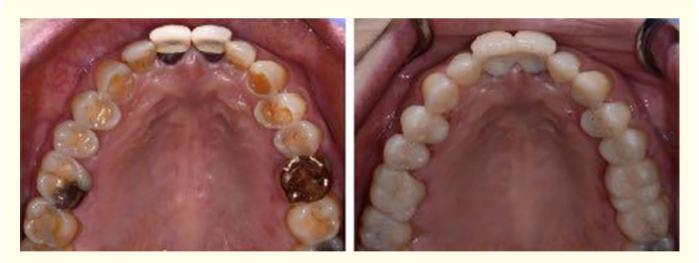
Figure 6: Occlusal view of provisional restorations.

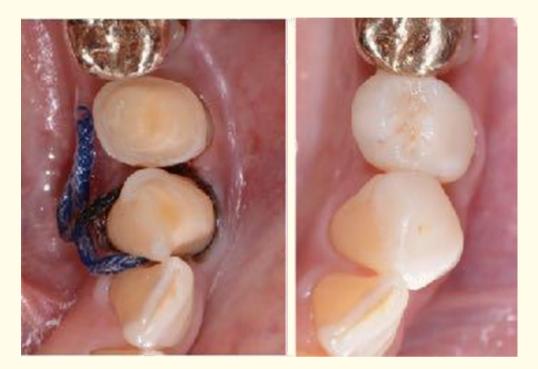
Figure 7: Preparation of teeth No. 21 and 21 with final restorations.

The restorative phase continued with preparation the teeth in segments, starting with tooth #21 for onlay preparation and tooth #22 for Veneer preparation. Final impression has been made using Custom tray and PVS impression material. The final restoration were made with Lithium disilicate (IPS e.max Press) and bonded to teeth with Resin cement (Variolink Esthetic, Ivoclar Vivdent) (Figure 7,8). After

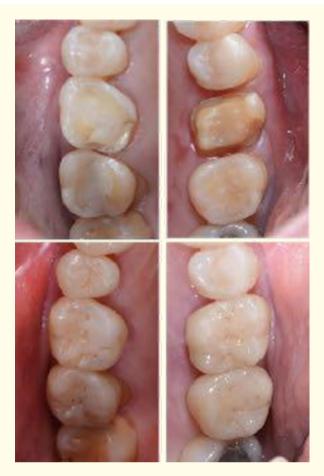
*Figure 9:* Preparation of teeth No. 2,3,14,15 with final restorations.

that minimal Onlay preparation have been done for teeth # 2, 3, 14,15 followed by the same steps for the previous teeth (Figure 9,10). Final segment was for teeth # 4,5,6,7,10,11,12,13 for onlay preparation and # 8 and 9 for Full coverage single crowns (Figure 11,12). At the conclusion of the treatment, an occlusal guard was provided to the patient helping her protecting her restorations (Figure 13-16).

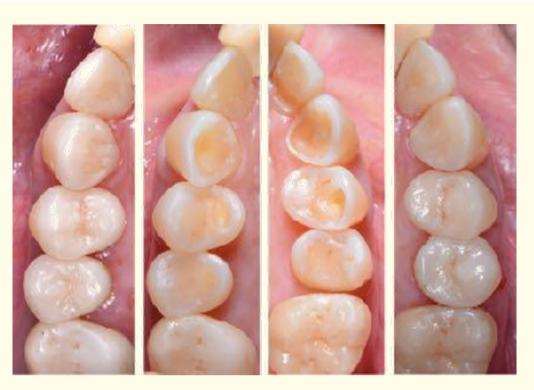
Figure 11: Preparation of teeth 4,5,6,7,10,11,12,13 with final restorations.

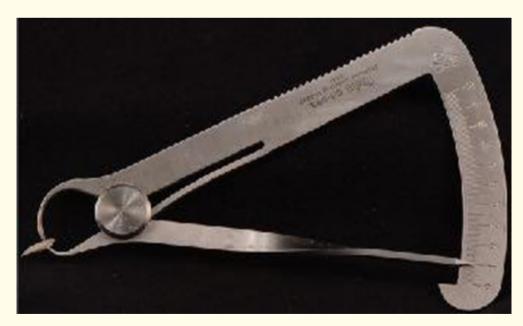
Figure 12: Restorations thickness ranged between 1 - 1.3 mm.

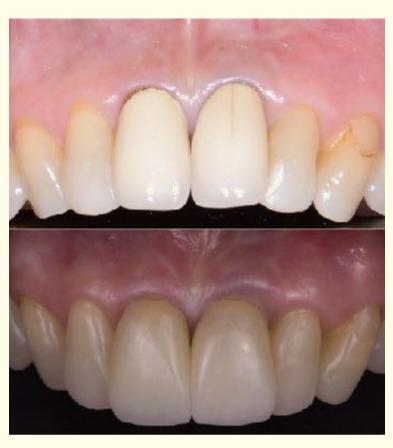
Figure 13: Final emax crowns restorations on teeth No. 8 and 9.

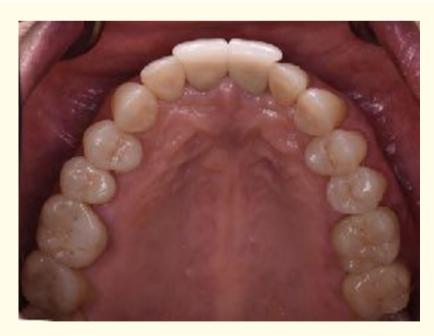
Figure 14: Final restorations - Occlusal View.

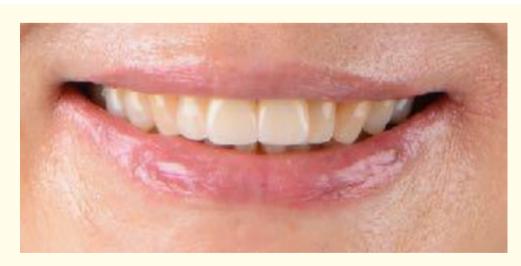
Figure 16: Patient Smile - Post treatment.
