## Indirect Ceramic Restoration Repair Technique in the Aesthetic Zone: Report of 2 Cases

Repair of restorations that failed for technical reasons or due to fatigue could certainly prolong the survival of functioning restorations. A technique for repairing fractured porcelain fused to metal restorations is presented. This technique uses a new overcasting (metal-ceramic or all-ceramic) crown that is cemented on the prepared fractured retainer of the prosthesis. The clinical and laboratory procedures are simple. The primary advantage of this technique is that it may be more predictable than the direct-repair method using composites, especially for situations in which a large portion of porcelain is missing. Also, this technique produces an aesthetic result that is more satisfying and stable than that of composite resins.

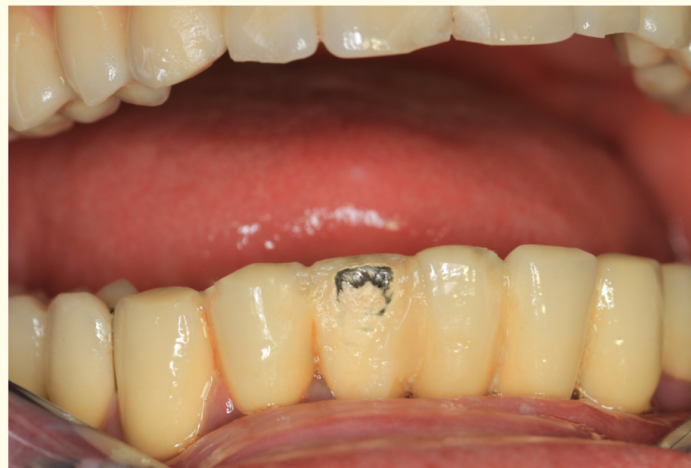
**Case 1:** A 60-year-old patient came to the private practice asking to restore his aesthetic appearance. The clinical examination revealed that there was a 6-unit fixed partial denture with broken porcelain on the labial surface of the right central incisor of the mandible (41). The opposite teeth were intact. According to the patient's report, the fractured restoration had been fabricated 13 months prior (Figure 1A).

*Figure 1A: Fractured metal-ceramic retainer: initial aspect.*

There were three alternative treatment options, which were presented to the patient: replacement of the fractured prostheses with a new one, direct repair of the fractured ceramic surface with the use of ceramic repair materials, and light-polymerized composite resin, or replacement of the fractured abutment with an overcasting.

The patient refused replacement with a new one due to financial difficulties, discomfort, and time. Repair of the fracture surface with the use of ceramic repair materials was considered not such a good solution because it has no long-term prognosis. Consequently, the third treatment option of repair with an overcasting was selected.

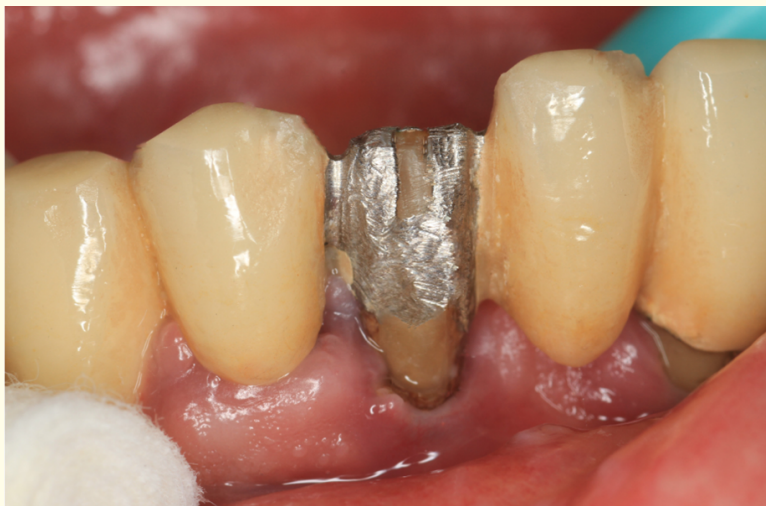
**Figure 1B:** Labial view of the preparation.

All clinical procedures of the indirect repair were done according to the previously published technique [6,7]. The fractured abutment was evaluated clinically and radiographically to assure that the abutment tooth was in good condition. Using a fine diamond rotary cutting instrument (38GS Uniprep C&B Set, Intensive, Switzerland) all remaining ceramic material was removed from both the facial and the lingual surface. During this procedure, great care was paid to avoiding grinding the adjacent ceramic and the connector area of the original restoration. A chamfer finish line was created on the lingual aspect of the original crown, in the cervical area and the metal along the facial chamfer was removed to simplify finishing and to prevent a cement line. After preparation, the occlusion was checked. Because there wasn't adequate space with the opposite teeth, metal was almost totally removed in the incisal and middle third of the abutment to achieve the necessary reduction (~ 2 mm) [7] (Figure 1B and 1C). After the preparation was finished, a temporary crown was constructed using self-polymerizing acrylic resin (Luxatemp Handmix, DMG Co) and cemented with non-eugenol provisional cement (E.T.C. Parkell Inc.). The final impression was made with a siloxane material (Speedex, Coltene -Whaledent Co). An impression of the opposite teeth was made, using an alginate impression material (Cavex impressional, Cavex Co). Also, an interocclusal record was made (Luxa Bite, DMG Co).

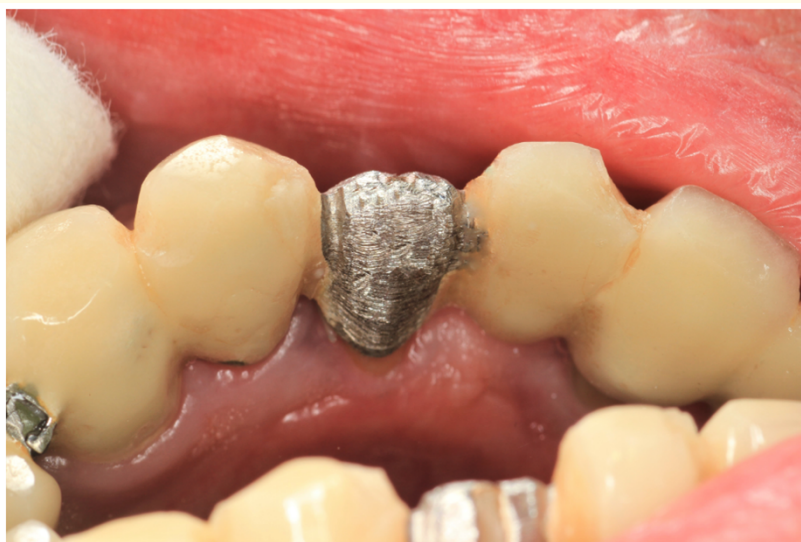
**Figure 1C:** Lingual view of the preparation.

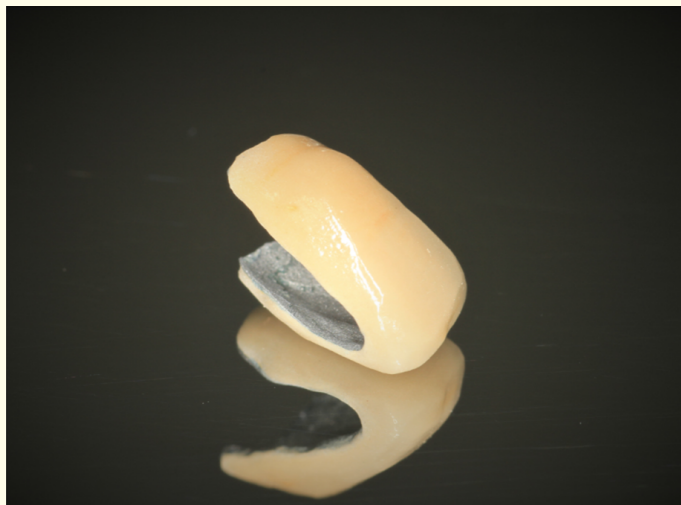
**Figure 1D:** The new metal-ceramic crown.

In the laboratory, a wax coping was made and the framework was cast with a base metal alloy suitable for metal-ceramic restorations (Wiron 99, Bego, Germany). For the final restoration, feldspathic porcelain (VMK 68, Vita Zahnfabrik, Germany) was used (Figure 1D).

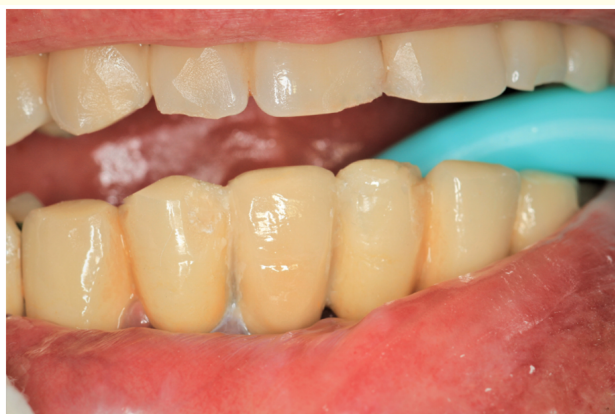
**Figure 1E:** Labial view of the cemented new restoration.

After that, the overcasting crown was evaluated intraorally and the occlusion was checked. At the last appointment, the completed metal-ceramic overcasting crown was cemented, using a rubber dam for isolation. The inner surface of the overcasting and the lingual and labial surfaces of the fractured abutment were sandblasting with 30  $\mu\text{m}$  silica oxide particles (Cojet Sand, 3M-Espe, Germany) for 15 sec using an intraoral air abrasion device (CoJet System, 3M-Espe, Germany).<sup>19</sup> The cementation was done using Panavia 21 (Kuraray, J Morita Co. Ltd, Osaka, Japan) according to the instructions of the manufacturer.

The patient was satisfied with the final result and entered into a maintenance program. Figure 1E and 1F shows the final aspect of the repair.

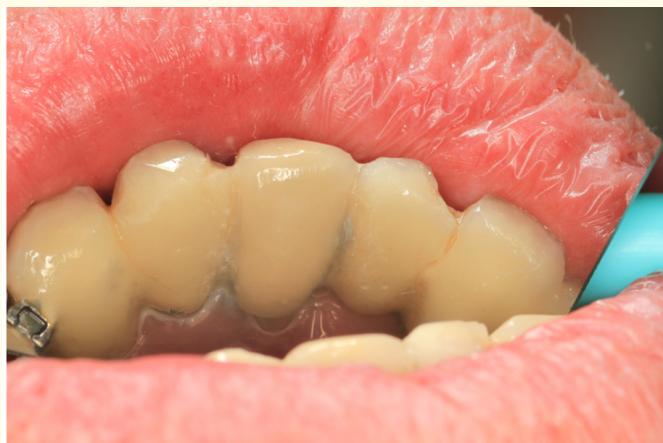
**Figure 1F:** Lingual view of the cemented new restoration.

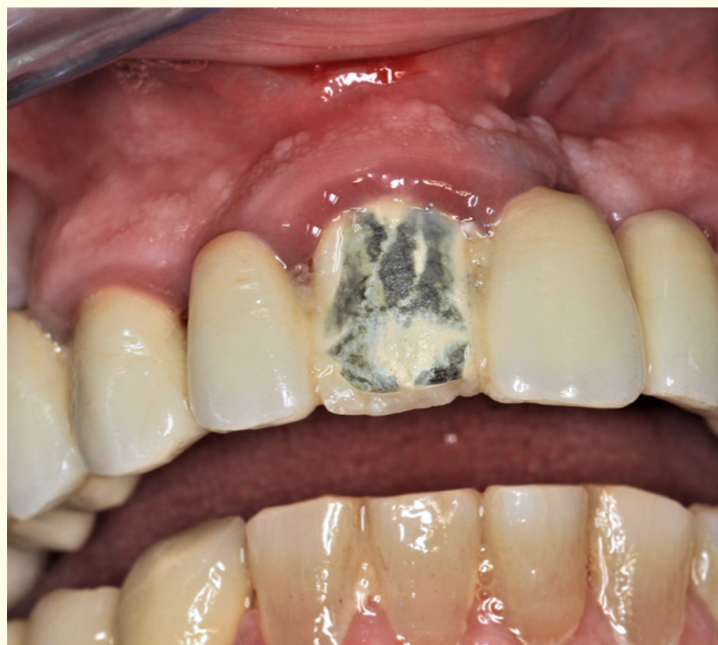
**Case 2:** A 35-year-old woman with a 6-unit fixed prosthetic restoration presented in the private practice with almost total labial surface ceramic detachment of maxillary right central retainer (Figure 2A). According to the patient’s report, the fractured restoration had been fabricated 2 years ago and trauma caused the failure.

**Figure 2A:** Initial aspect of the fractured metal-ceramic retainer.

Complete replacement of the prosthesis was recommended, but the patient preferred quick and conservative repair of the restoration. The direct repair method with composite resin was considered not such a good solution because of the bulk of fractured porcelain. An indirect repair method with an overcasting crown was therefore selected.

The patient was a famous actress and was very interested in her aesthetic appearance. Thus, it was decided to repair the broken abutment with a zirconium all-ceramic crown, that offers a better aesthetic result, especially in the cervical area.

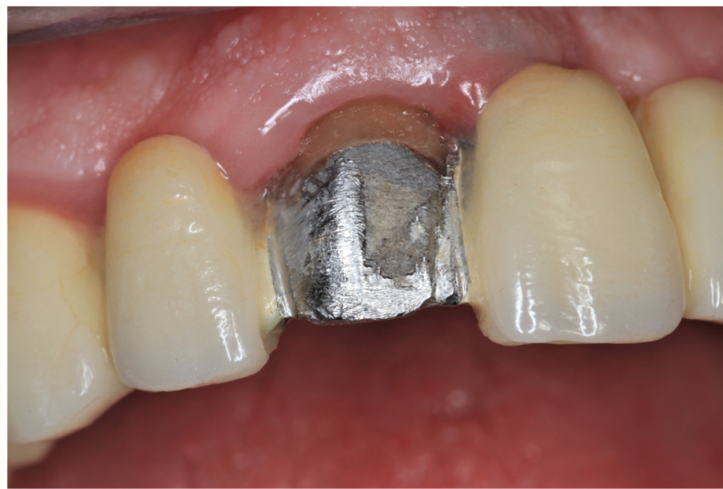
*Figure 2B: Labial view of the preparation.*

The preparation of the fractured abutment was done in the same way as in case 1 (Figure 2B and 2C).

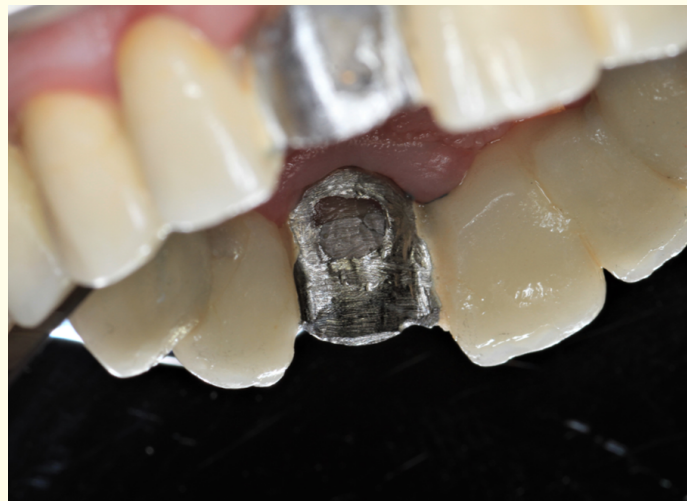
*Figure 2C: Lingual view of the preparation.*

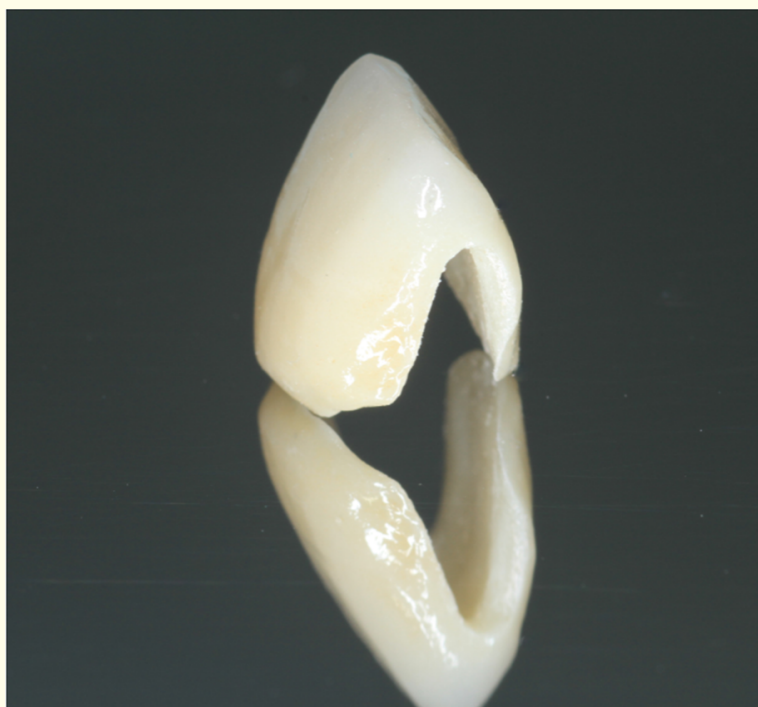
**Figure 2D:** The new “modified” zirconium all-ceramic crown.

In the laboratory, the technician manufactured a “modified” zirconium all-ceramic crown. The term “modified” was applied because part of the mesial and distal structure of the crown was missing (Figure 2D).

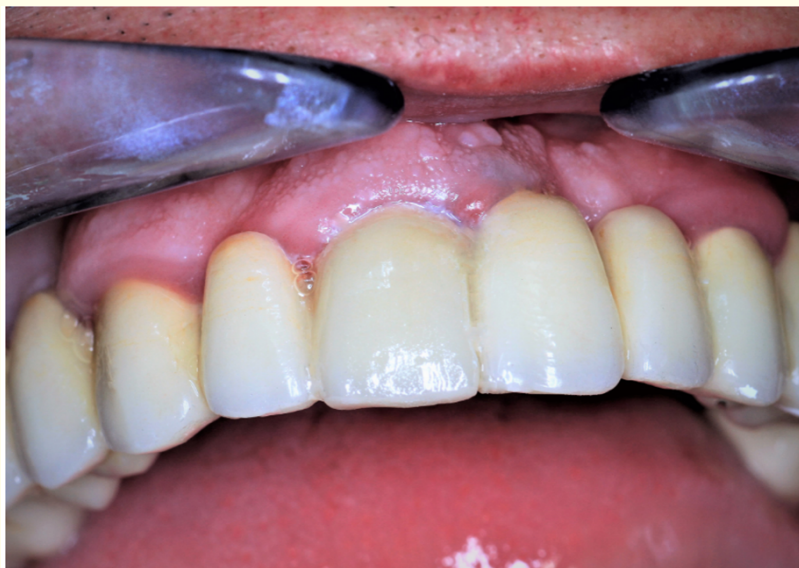
**Figure 2E:** Labial view of the cemented new restoration.

At the last appointment, the completed all-ceramic overcasting was cemented in the same way as in case 1.

The patient was satisfied with the final result and entered into a maintenance program. Figure 2E and 2F shows the final aspect of the cemented new restoration.
