Multidisciplinary Treatment Approach for Crown Fracture: 18 Years Follow Up

The purpose of this clinical report is to describe the eighteen years follow up of a young patient with a fractured tooth, initially treated by flap surgery with ostectomy, endodontic treatment, reattachment of tooth fragment combined to direct restoration with resin composites and now restored by a ceramic crown.

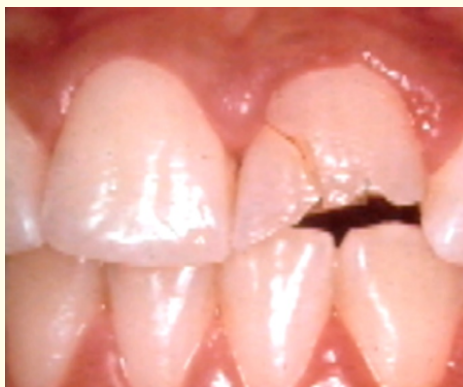
Figure 1: Fractured maxillary left central incisor.

Although the tooth fragment was mobile, it was still in place. Intra-oral examination revealed that the fracture was located subgingivally on the palatal aspect of the tooth, with a probing depth of 5mm on the distal palatal site and bleeding on probing. Pulpal exposure was clinically and radiographically confirmed. However, radiographic exam could not clearly show the depth of the fracture, which was only observed after the fragment removal.

The patient’s parents were informed about possible treatment options and a decision was made to treat this complicated subgingivally fractured permanent central incisor by periodontal flap procedure + ostectomy, endodontic treatment and reattachment of the tooth fragment combined to direct restoration with resin composites (Z-100 - 3M Oral Care, St. Paul, MN, USA; Charisma - Kulzer, Tokyo, Japan; and Durafil Kulzer), as described in the previously published case-report [18].

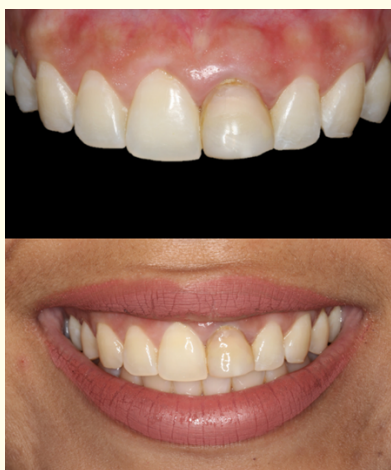
Clinical examination revealed an unsatisfactory discolored composite veneer on left maxillary central incisor. Shape and volume of composite restoration were inadequate, as well as polishing and texture in general. Moreover, the tooth was slightly brownish and distally tipped, turning the smile disharmonious (Figure 3). Overall, endodontic and periodontal condition was stable; no periapical defects, no deep probing depth and no bleeding on probing were noticed. During clinical examination, a single caries was found on cervical margin of right maxillary central incisor. The radiographic exams revealed that a glass fiber post was cemented on the root canal, probably in order to ensure higher retention and support to the restorative material (Figure 4).

Figure 3: Buccal view (above) and aspect of smile (below) 18 years after first treatment.

Treatment options were presented to the patient and potential risks and complications of each choice were discussed. Considering the high esthetic result demanded by the patient and all previous treatment already performed, the selected treatment included dental bleaching, direct composite restoration of right maxillary central incisor and ceramic crown on left maxillary central incisor.

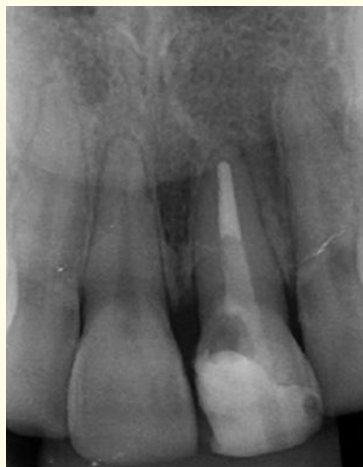
Figure 4: Radiograph taken 18 years after first treatment.

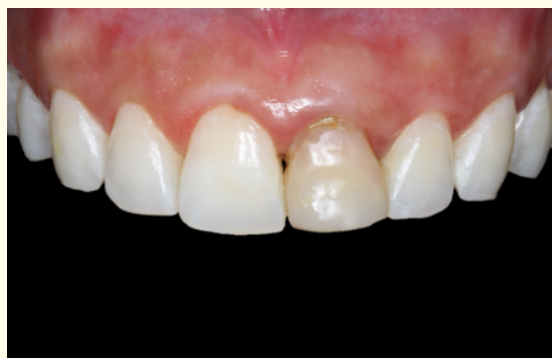
Figure 5: Buccal view after completion of home bleaching and final restoration of right maxillary central incisor.

Fifteen days after completion of home bleaching, the patient's teeth looked much lighter and the final restoration with resin composite (Filtek Z350 XT, 3M Oral Care) was performed on cervical margin of right maxillary central incisor (Figure 5).

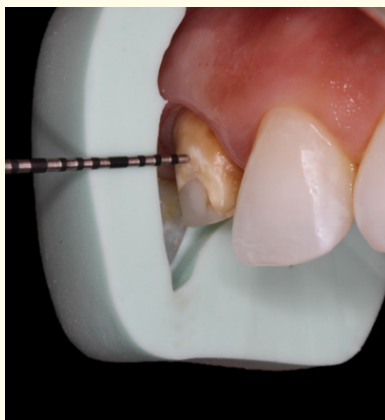
Figure 6: Silicone matrix guide placed over the tooth, evidencing the total amount of wear.

Preparation of left maxillary central incisor was performed initially through peripheral delimitation with #1016 spherical diamond bur (KG Sorensen, Cotia, SP, Brazil) at cervical margin, on facial and lingual surfaces. A cylinder, round-end #3146 diamond bur was then used to prepare tooth facial surface, taking into account axial inclinations - cervical, medium and incisal, reducing 2.0 mm of total facial surface. In this step, the use of previous mentioned silicone impression matrix was important to guide the amount of wear. Proximal margins were defined also with #3146 diamond bur, first protecting adjacent teeth with metal strip (TDV Dental, Pomerode, SC, Brazil) and wearing the proximal margin of left central incisor with #2200 diamond bur. The incisal edge was reduced for about 2 mm, from interocclusal distance, with round facial incisal line angles. Then, an ovoid #3168 diamond bur was used to prepare the lingual surface, considering its typical concavity. Finally, in order to obtain 6° expulsiveness, a tapered-cylinder round-end #4138 diamond bur was applied over proximal surfaces, and a #4137 diamond bur regularized the facial surface, begetting a round shoulder finishing line intrasulcular located. To finish the preparing a #0 retraction cord (Ultrapak, Ultradent Products) was inserted into gingival sulcus to expose all prepared surface area; all angles were rounded, and surfaces were finished and polished with extrafine diamond burs, aluminum oxide polishing discs (Sof-Lex contouring and polishing discs, 3M Oral Care), and abrasive silicone tips (Optimize, TDV Dental, Pomerode, SC, Brazil). Figure 6 presents the silicone matrix guide placed over the tooth, evidencing the total amount of wear, while figure 7 shows the final aspect of tooth prepared for ceramic crown. Herein, it is important to note the brownish shade of substrate, which led the wear amount of 2 mm.

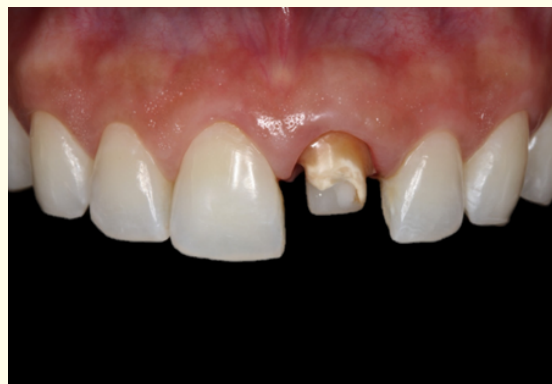
Figure 7: Final aspect of tooth prepared for ceramic crown.

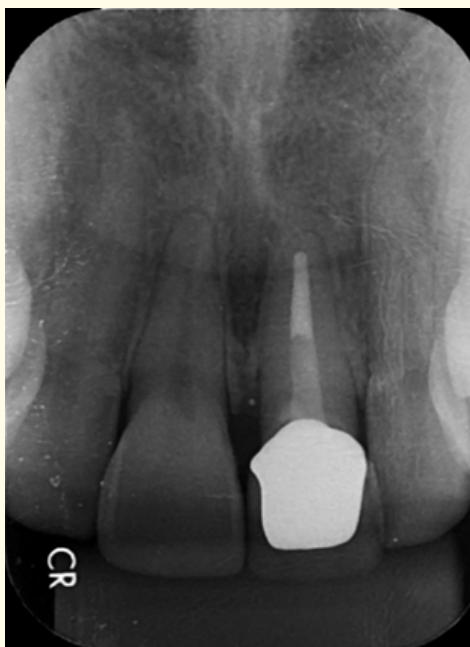
After a week, the patient returned for clinical evaluation. Intra-oral and radiographic evaluation revealed satisfactory function and periodontal health (Figure 9 and 10). She was pleased with the result of cemented ceramic crown (Figure 11) and new smile obtained (Figure 12).

Figure 9: Final radiograph.

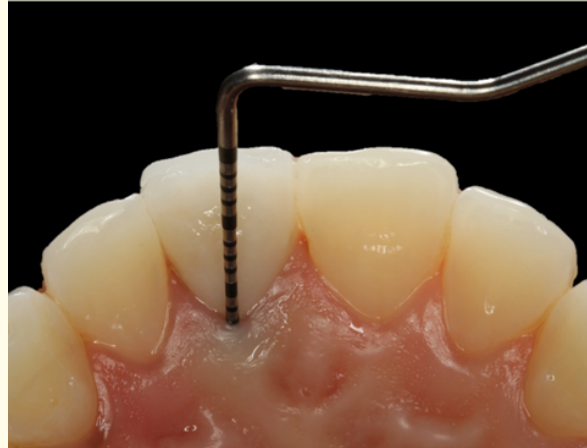
Figure 10: Periodontal health, evidenced by periodontal probing.

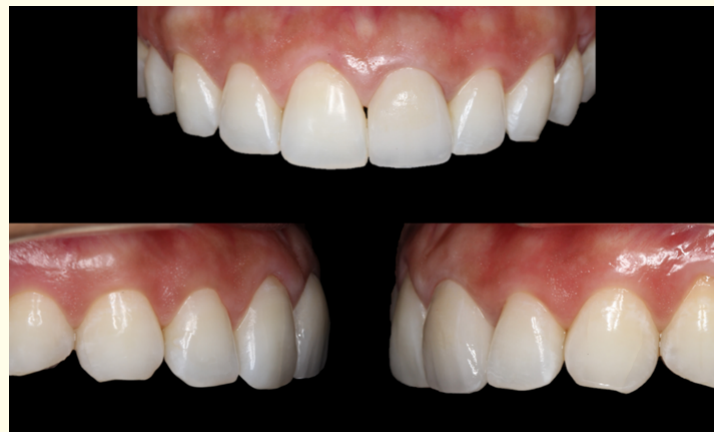
Figure 11: Final buccal view (above) and lateral view (below).

Ceramic crown was cemented using A1 shade of RelyX Ultimate dual cure adhesive resin cement (3M Oral Care) following manufacturer's instructions. Cement excesses were firstly light-cured for 5 seconds and were gently removed. Then, further 40 seconds of light-curing was performed on facial, lingual, incisal, mesial, and distal segments. The retraction cord was taken off from gingival sulcus and removal of cement excesses from proximal and cervical surfaces was performed using metal strip and scalpel blade. Rubber retractor was removed and restoration margins were polished with abrasive silicone tips (8090D Finishing and Polishing Kit, KG Sorensen).

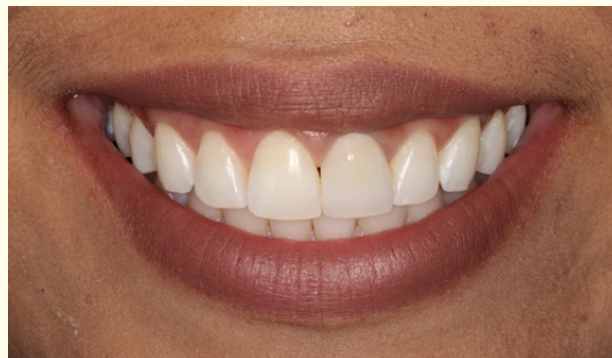
Figure 12: Final aspect of smile.
