Guidelines for Orthodontic Considerations in Impaction of Maxillary Central Incisor with Dilaceration

Keywords: Orthodontic Considerations; Maxillary Central Incisor; Dilaceration

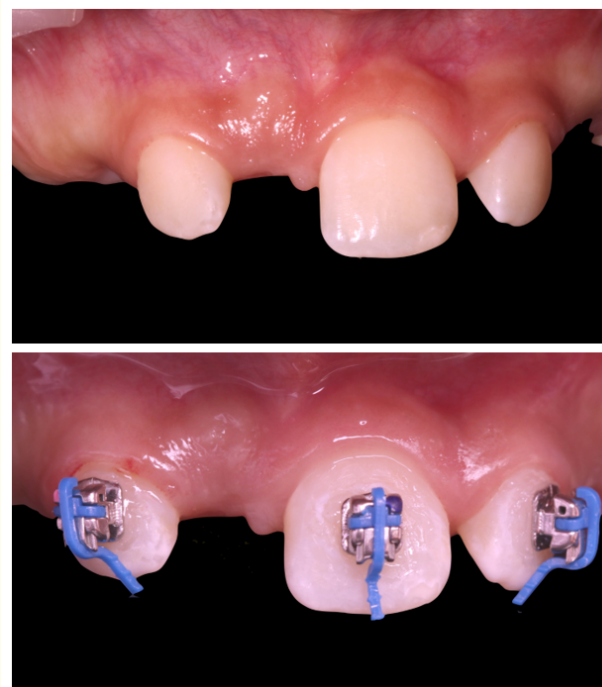
Figure 3: This figure demonstrates a closer view to the space left for the central incisor before and after bonding the brackets.

A: Shows the condition before bonding where a very little space is present for the missed tooth.

B: Shows the position of the brackets at the teeth adjacent to the impacted central incisor.

The process started by conditioning the available teeth for bonding, etching the tooth, applying a layer of bond, and preparing the brackets for bonding them on the teeth. The brackets used in this case are self-ligating double-slot system brackets for more anchorage control as will be illustrated later (Figure 3).

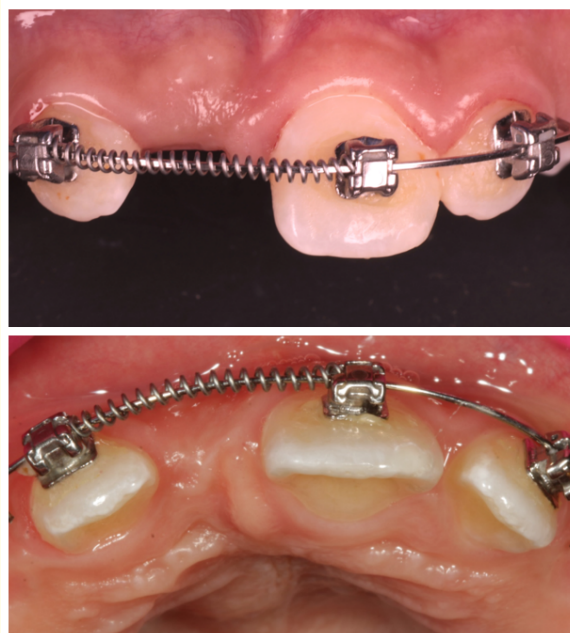
Figure 4: This figure shows the open coil that was placed for gaining space for the impacted tooth.

A: Shows frontal view.

B: Shows occlusal view.

This case suffered from midline shift due to impaction. The repositioning of every tooth back to its original location is added to the treatment for midline correction. After the leveling and alignment, an open coil spring was placed to correct the midline and to allow some protrusion to help correct class III malocclusion (Figure 4).

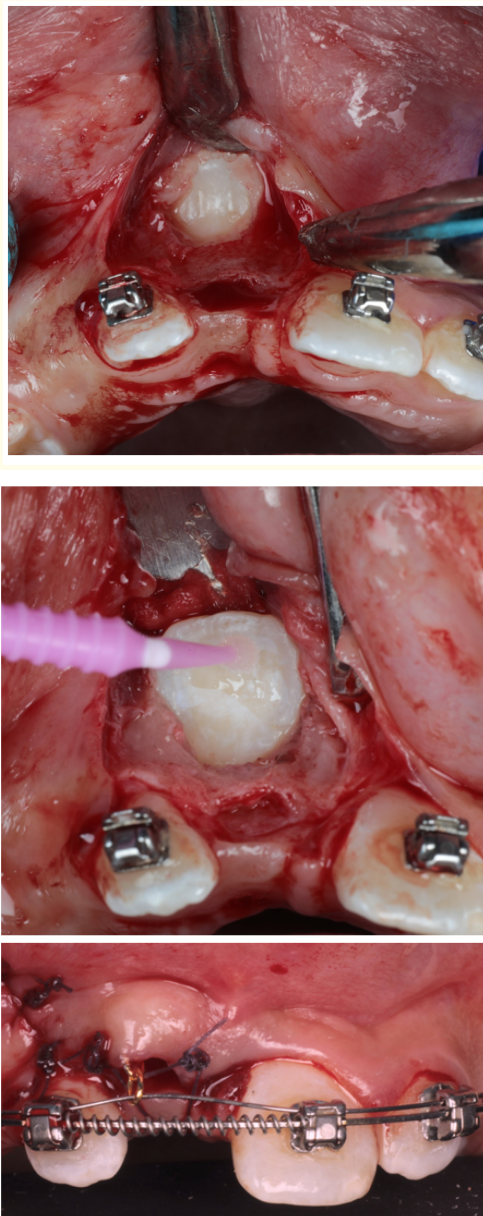
Figure 5: These figures shows the first surgery in which we used “closed traction technique”.

A: Flap reflection and tooth exposure.

B: Tooth conditioning for bonding.

C: Condition of suturing just right after the surgery, double wire technique, gold chain presented to connect the impacted tooth to the NiTi wire.

The first surgery was closed eruption which somehow has high technique sensitivity (Figure 5).

The surgery began with an incision in the impaction area with a flap reflection. Some of the bone around the tooth was removed to uncover the tooth. After bone removal all around the tooth, some bone was removed from the pathway of the tooth to allow it to erupt. A golden chain with eyelet was placed over the palatal surface of the tooth. This chain will help traction the incisor without the perforation of the nasal floor due to its proximity. The Gold chain is mentioned in the *American Journal of Orthodontics and Dentofacial Orthopedics* to have one of the most flexible means of traction. Subluxation was performed before flap closure, finally the flap was closed and sutured to allow orthodontic traction to begin with the help of orthodontic wires.

Double-wire technique was made using two wires: a major wire passing through all brackets sized 0.019 x 0.025 SS and a secondary wire passing through the golden chain had to be a flexible wire as Nickel Titanium (NiTi) wire 0.012. This wire passes through the holes of the chain and is activated by passing through the consequent hole for more traction.

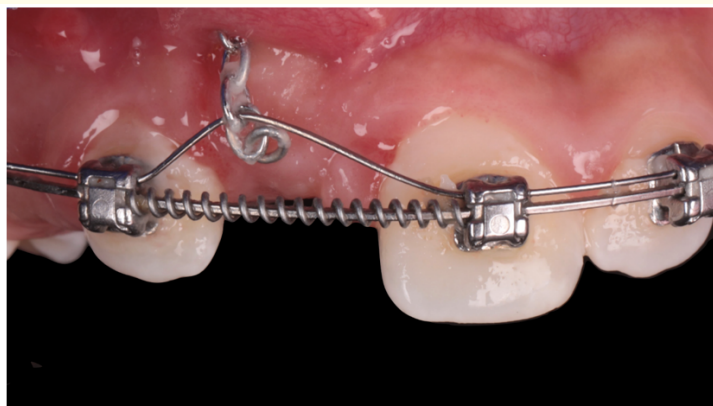
Figure 6: This figure shows the double wire technique and the progress happened after couple of months follow up for the traction of the tooth.

The patient kept visiting the clinic for monthly activation of the chain by moving the NiTi archwire throughout the golden chain holes apically (Figure 6).

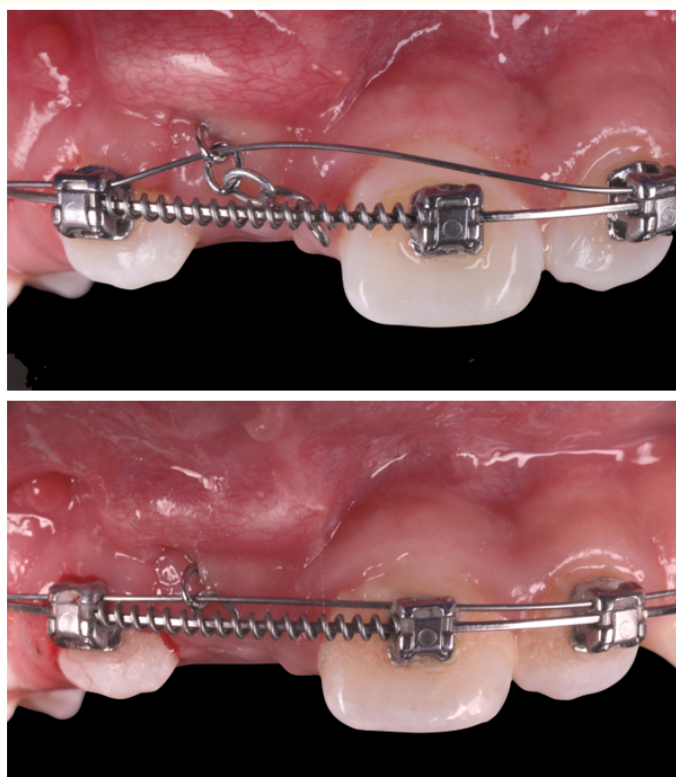
Figure 7: After 4 months of Activation of the old chain and Follow-up. The tooth became in a closer position to the ridge and can be palpated.

The difference between A and B in the process of activation of the wire.

After four months of follow up the tooth started to get closer to the alveolar ridge and was finally palpated through the labial gingiva (Figure 7).

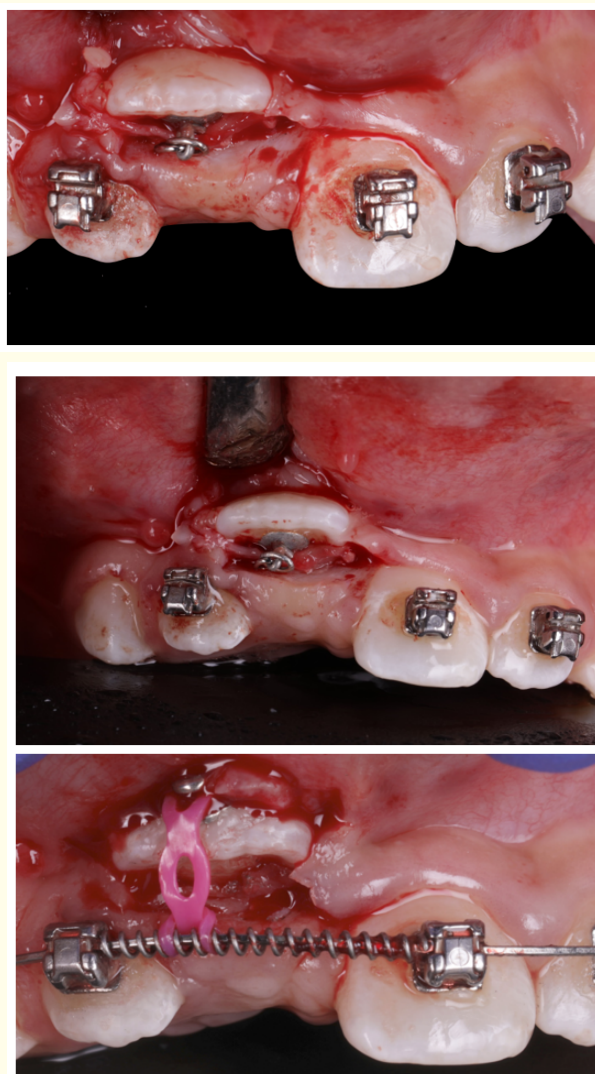
Figure 8: This figure shows the second surgery.

A and B: Apically positioned flap.

C: The Button applied over the tooth, power-chain for retraction and the coil over the wire connected to the power-chain which is applied over the button bonded to the tooth.

The central incisors were re-exposed and components to further help in its eruption: A gold chain was removed, and button was bonded labially, and an elastic power chain was applied vertically on a rectangular Stainless Steel wire (Figure 8).

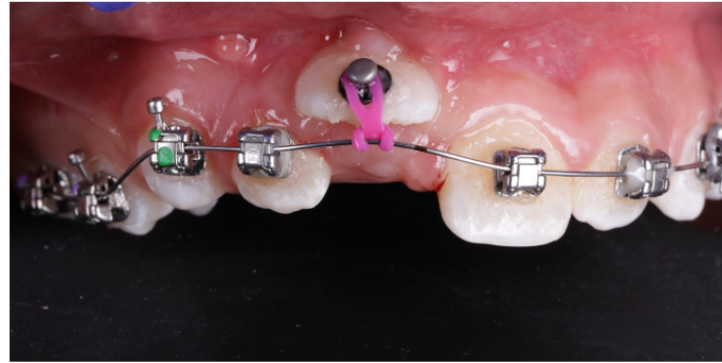
Figure 9: Replacing the button in a more centralized position after well traction and approximation of the tooth to the alveolar ridge. Continued traction was made through the power-chain.

The patient made monthly follow-ups until the tooth was correct in position. A button is placed in a more centralized position over the tooth (Figure 9). The tooth is erupted and conditioned with a bracket on the tooth to start to correct its alignment (Figure 10). A double wire technique is made again. A step bends in a stainless steel rectangular wire for anchorage and to prevent the tooth touching the main

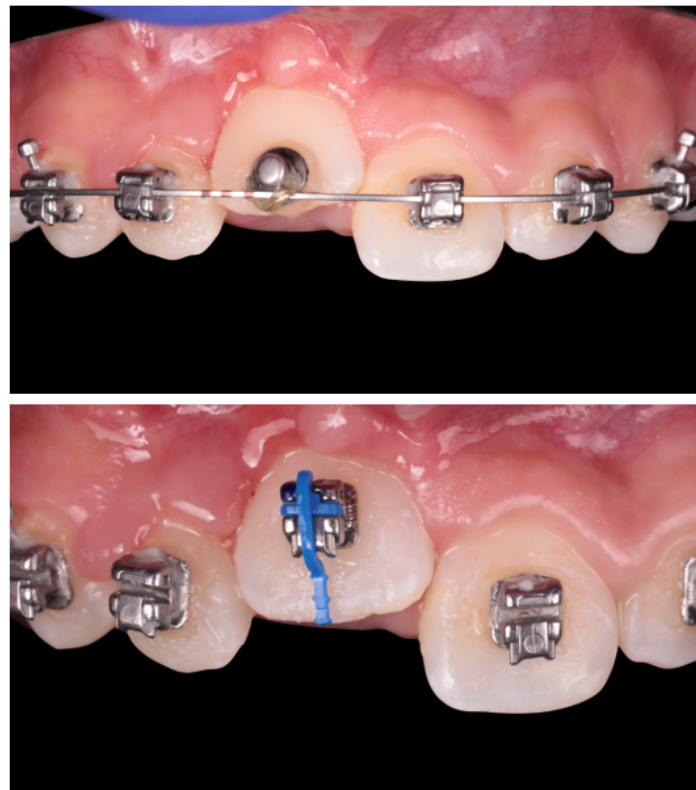
Figure 10: Shows new position of the tooth and the replacement of the button in "A" with the bracket in "B".

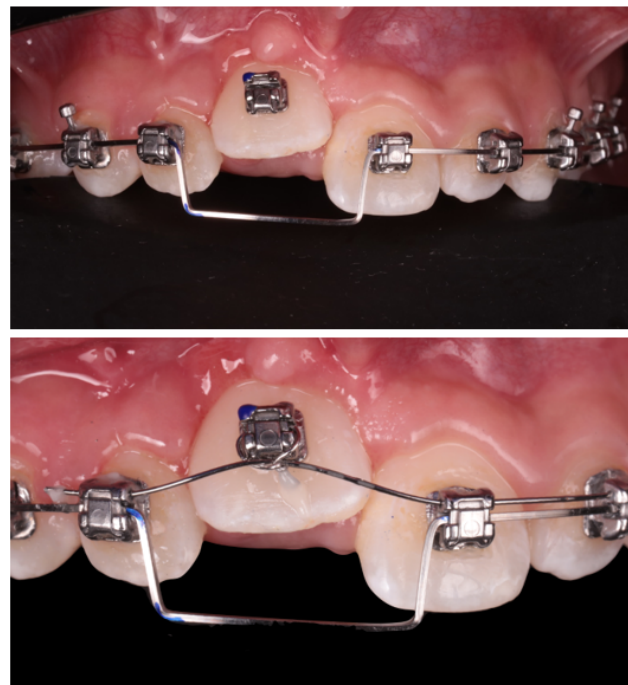
Figure 11: A: Shows a bend in a stainless steel rectangular wire.

B: Shows an extra wire NiTi size 12 to be used in a double wire technique. We used ligature tie to prevent occurring of a bend due to increased angle between the tooth and the wire.

wire and be obstacle in its eruption path. The second wire used is NiTi size 12 wire to be flexible for further traction. A ligature wire is used in the case to decrease the angle between the tooth and the wire for more safe traction and gingival healing (Figure 11).

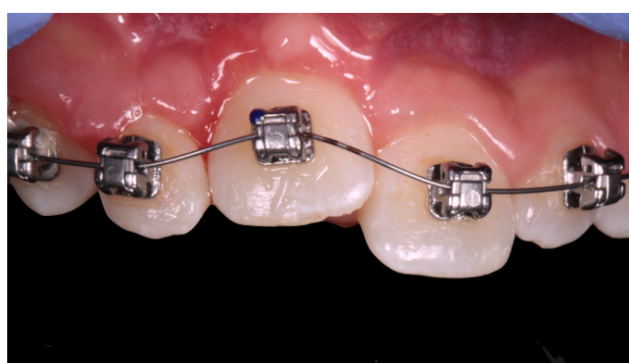
Figure 12: After the approximation of the tooth to the rest of adjacent teeth we inserted the wire directly in the bracket.

The whole tooth has erupted in the alveolar ridge. The wire is inserted directly in the bracket of the previously impacted tooth. The bonding of the erupted teeth in the upper and lower arches was made after their eruption and included the whole arch in the orthodontic treatment for proper alignment (Figure 12).

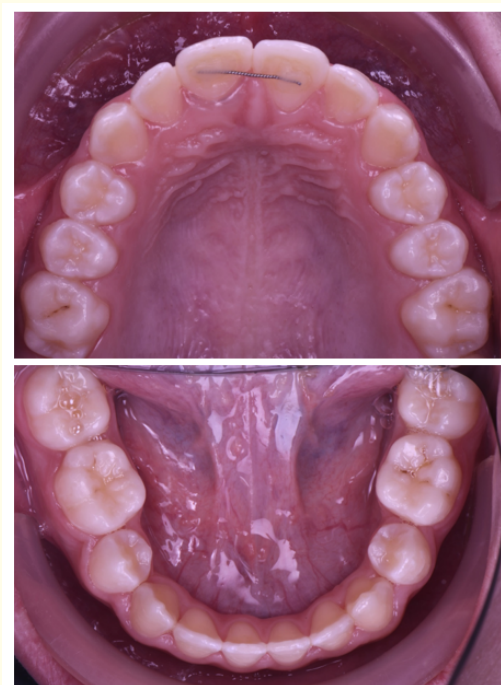
Figure 13: A figure showing post-operative photos to show how the tooth is well aligned in the arch and the appearance is completely healthy and natural.

The whole phase took two years. The patient was completely satisfied by the results of both the eruption of the impacted tooth and the almost normal appearance of the occlusion (Figure 13).

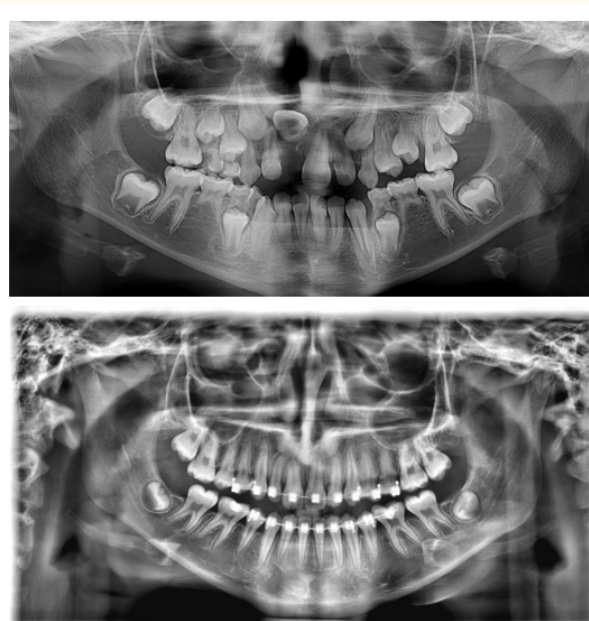
Figure 14: This figure shows the differences presented in the old panorama (A) and the new panorama made after the treatment (B).

Post-operative photos and radiographs were taken for documentation to be viewed by the patient and for further studies. The gingiva appeared healthy and its color was good. The periodontal condition of the tooth was assessed and was adequate (Figure 14 and 15).

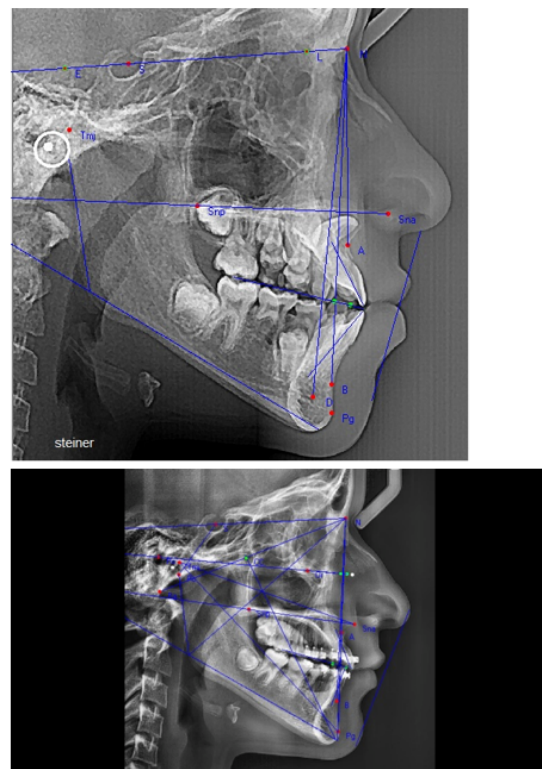
Figure 15: A: Pre-operative cephalometry along with analysis lines to the patient compared to B: the postoperative cephalometry where the position of central incisors and the condition of the occlusion and their differences are clear.
