Immediate Reimplantation at Failed Osseointegration Sites: A Drilling and Systematically Increasing Implant Width Protocol to Ensure Primary Stability

Leon Chen^{1*} and Niq Chen²

¹Chairman/CEO, Dental Implant Institute, Las Vegas, NV, USA

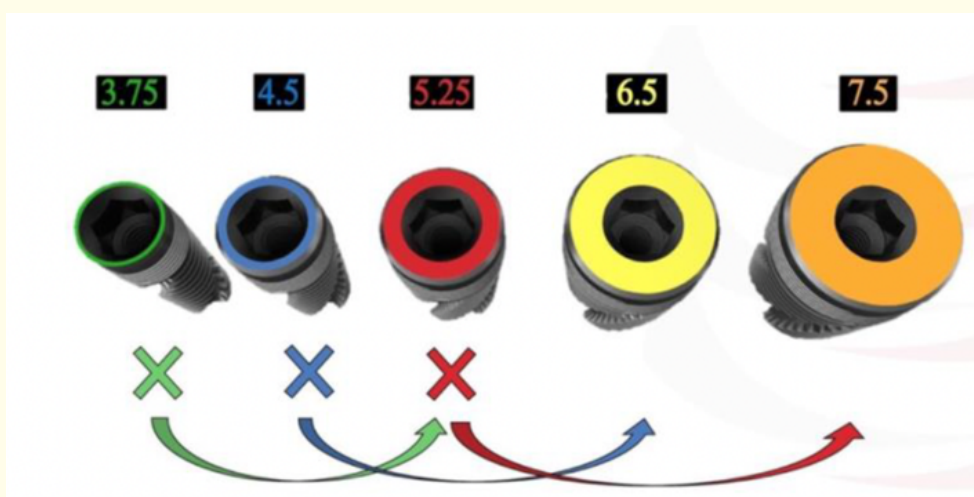
Figure 1: The rationale behind the logically developed width increments of the OsseoFuse® implants are ensuring that in the unlikely event of osseointegration failure, an implant two width sizes larger could be placed immediately into the original osteotomy site for optimal primary stability.

To follow a systematic contingency plan, some implant systems are intentionally designed with incrementally increasing diameter sizes (e.g., HexaPlus™, OsseoFuse®; SinusFuse®, OsseoFuse®), rather than a range from small to extra-large. The rationale behind the logically developed width increments is ensuring that in the unlikely event of osseointegration failure, an implant two width sizes larger could be placed immediately into the original osteotomy site for optimal primary stability and reduced patient discomfort (Figure 1) [13].

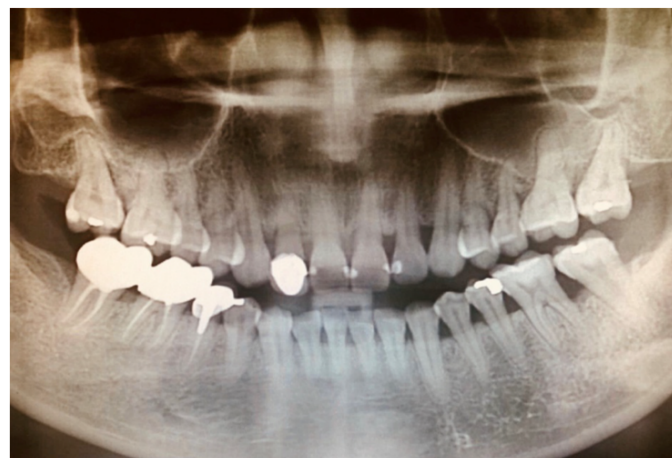
Figure 3: Preoperative panoramic radiograph of tooth #7 prior to extraction and immediate implant placement.

A 42-year-old woman presented in September 2011 with a chief complaint of persistent pain and pressure at tooth #7 for approximately 6 months. A thorough examination was performed, including radiographs (Figure 3), and a complete health history was taken. The woman was a non-smoker, with nothing remarkable in her health history. The examination revealed that the crown on #7 was broken; there was a vertical fracture; and severe localized periodontal disease with a compromised mobility of grade 2 was present. In consultation with the patient, the decision was made to extract tooth #7 and immediately place a dental implant (e.g. OsseoFuse® HexaPlus™ dental implant) and provisional restoration.

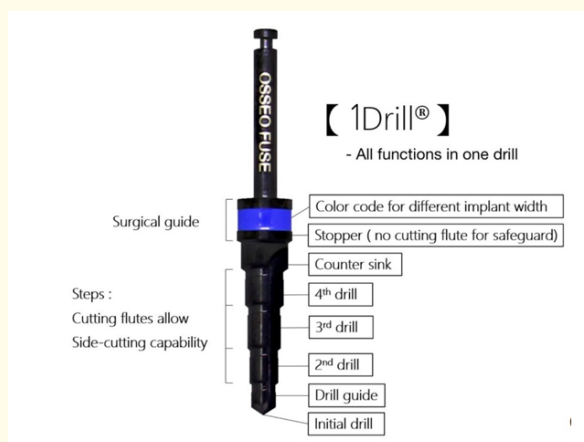
Figure 4: Illustration of the OsseoFuse® Onedrill®, which combines all the functions of multiple drills into a single drill, thereby allowing the dental implant surgeon to place implants in a shorter amount of surgical time.

In particular, the Onedrill® has a small diameter at the apical end continuing with a step incrementation of increasing diameter with each step all the way up to the stopper; colored to match the diameter of the selected implant (i.e. from smallest diameter to largest) (Figure 4). Therefore, there would be no need to interchange drills during the procedure, which would help to prevent error while simultaneously raising the predictability of the implant treatment success.

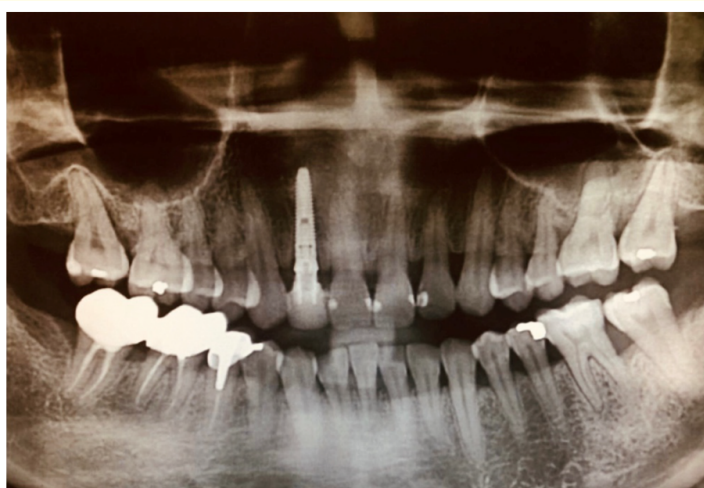
Figure 5: Immediate postoperative panoramic radiographic following extraction of tooth #7 and immediate placement of an OsseoFuse® HexaPlus™ implant and provisional restoration.

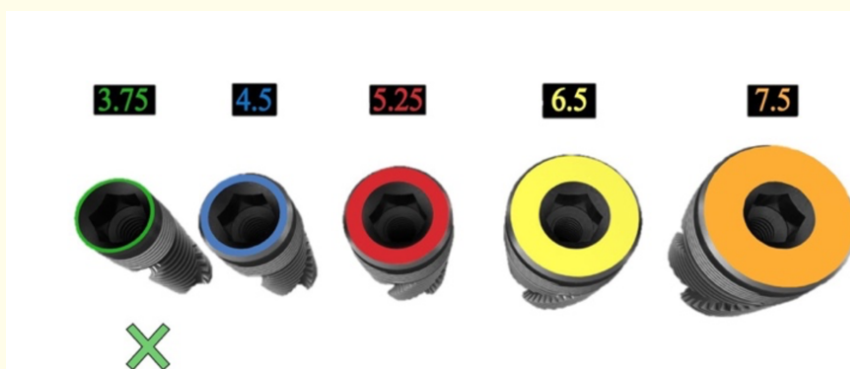
Figure 7: In this case, the 3.75 mm diameter implant failed to osseointegrate due to accidental trauma.

It was decided that the original 3.75 mm implant (Figure 7) would be removed and immediately replaced with a wider-diameter two sizes up, 5.25 mm implant (OsseoFuse® HexaPlus™) from the same product line (Figure 8). Addressing the trauma-induced osseointegration failure in this manner would provide the patient with several benefits.

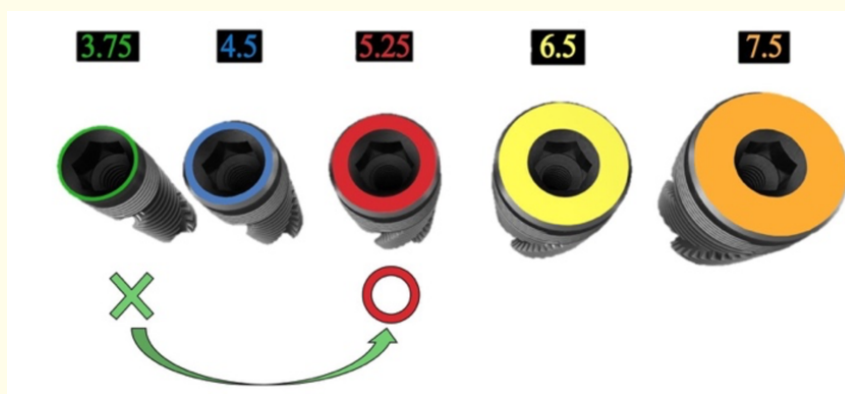
Figure 8: The poorly integrated implant was removed and immediately replaced with a wider diameter, 5.25 mm implant, without any further preparation or delay.

After cleaning out the fibrous tissue of the poorly integrated implant, we selected an OsseoFuse® implant two sizes wider (5.25 mm) than the previous OsseoFuse® implant (3.75 mm). The replacement implant was immediately placed with precision and without the need of further drilling and achieved optimal primary stability. A minimal amount of bone grafting material was again placed to fill any gaps between the implant and the extraction socket.

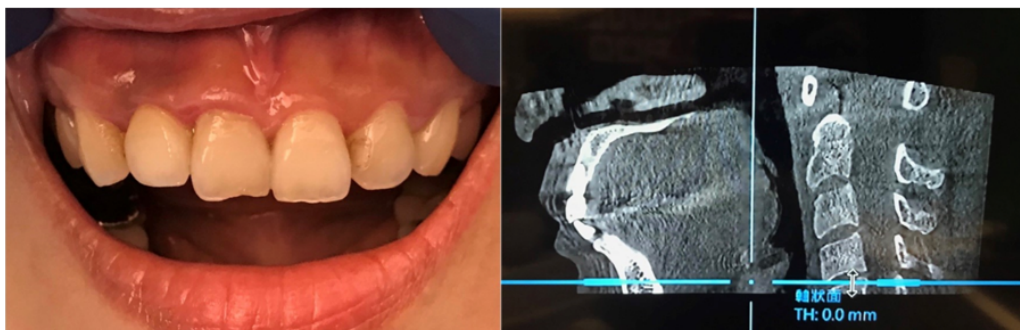
Figure 10: Clinical photographic and CBCT views taken 8 years after replacement of the failed implant and delivery of the final restoration.

Addressing the accidental traumatic implant osseointegration failure in this manner enabled the clinician to provide the patient with a time-sensitive, comfortable, and esthetic alternative to the conventional dental implant retreatment options. There was no need for her to wait months for retreatment or to undergo multiple uncomfortable surgeries. Additionally, after a recent follow-up with the patient, the retreatment with an implant two sizes larger, and the use of OsseoFuse® dental implants (HexaPlus™, OsseoFuse®, SinusFuse®, OsseoFuse®) has proven its long-term predictability, having been functioning successfully for more than 12 years (Figure 10).

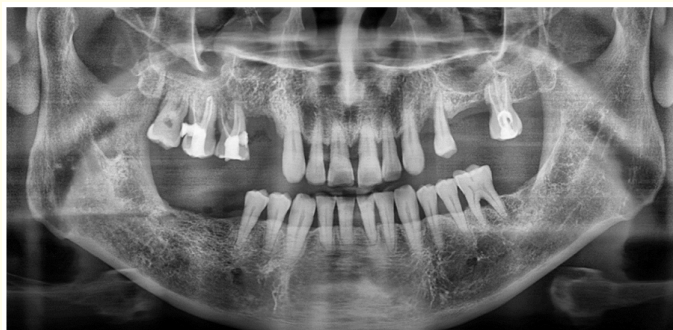
Figure 11: Preoperative panoramic radiograph revealing the hopeless nature and extent of infection and disease surrounding teeth #1 through 3, #13, #15, and #19.

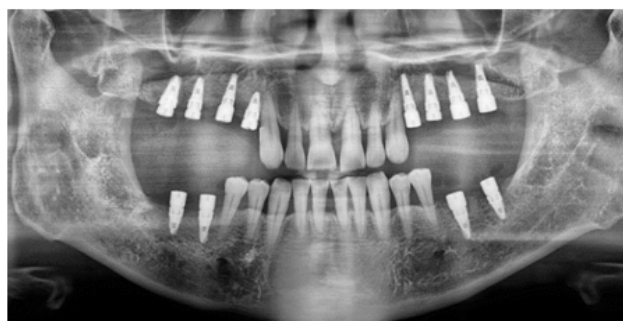
Figure 12: After the OsseoFuse® Onedrill® was used to create the osteotomies, 12 implants (i.e. sinus implants for maxillary arch; platform switching for mandibular arch) were immediately placed and provisionalized.

An immediate postoperative radiograph was taken (Figure 12), and the patient was dismissed with home-care instructions. All implants demonstrated proper healing during regularly scheduled follow-up appointments.

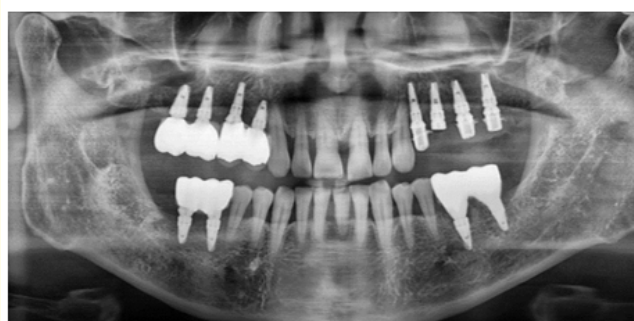
Figure 13: After four months, 11 implants demonstrated successful osseointegration, except the implant at #13, at which the patient reported experiencing slight pain upon palpating and percussion.

After four months of healing, the patient returned for final impressions, at which time all implants were sound and osseointegrated (Figure 13), apart from the implant at #13 site. At that site, the patient reported experiencing slight pain upon palpation, as well as pressure compared to the other 11 implants. It was decided that the original 3.75 mm implant would be removed and immediately replaced with a wider-diameter, 5.25 mm implant (OsseoFuse® SinusFuse®) from the same product line. Doing so would provide this patient with the same benefits as outlined in case presentation #1.

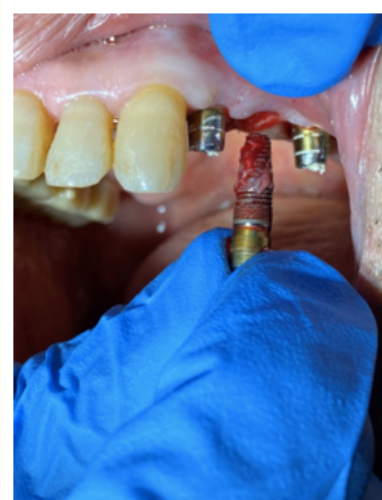
Figure 14: The 3.75 mm SinusFuse® at the #13 site was removed by counterturning.

Local anesthesia was administered to infiltrate both the buccal and palatal areas, and the poorly integrated dental implant at the #13 site was removed from the socket by counterturning (Figure 14), after which any residual soft tissue was also removed from the socket.

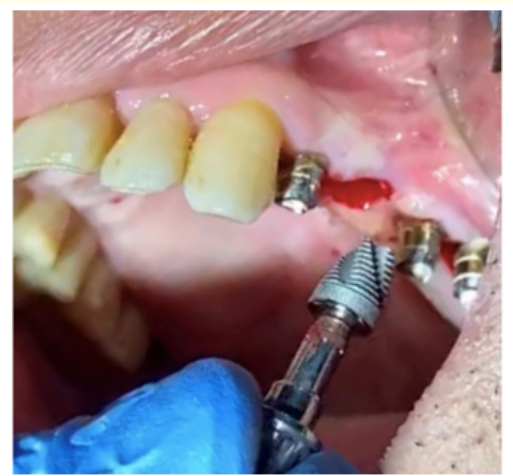
Figure 15: The implant at #13 was immediately replaced with a 5.25mm wide SinusFuse®, without the need for any further drilling or widening of the osteotomy.

The replacement OsseoFuse® implant was selected, which was two sizes larger in diameter (5.25 mm). The implant was placed immediately (Figure 15) and torqued to over 60ncm to achieve optimum primary stability, without any further drilling (Figure 16). A minimal amount of anorganic bovine bone grafting material was again grafted, and the original immediate provisional abutment and full-coverage crown were then placed again. A postoperative radiograph was taken (Figure 17), and the patient was dismissed in anticipation of receiving 11 final implant-supported restorations the following week.

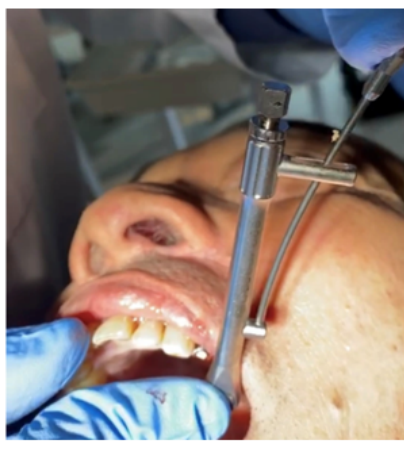
Figure 16: After the 5.25 mm SinusFuse® was placed, it was torqued to more than 60 ncm to achieve primary stability.

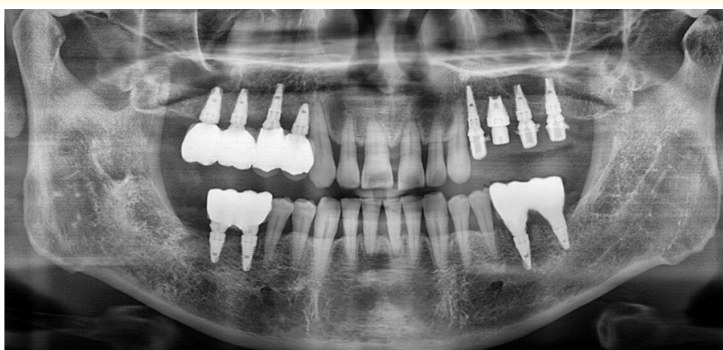
Figure 17: Postoperative panoramic radiograph following immediate reimplantation of #13 following removal of the failed implant.

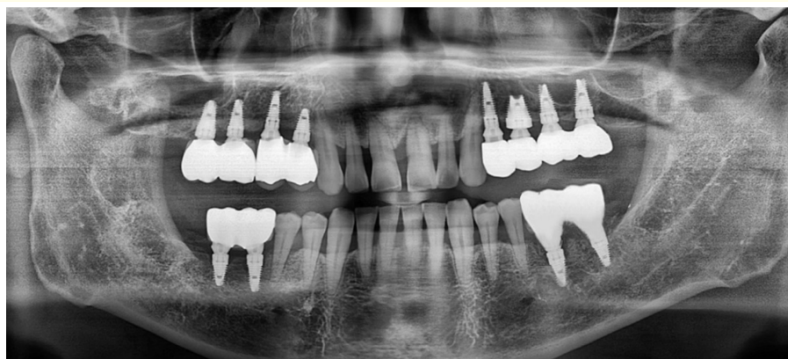
Figure 18: Panoramic radiograph four months later with final restorations.
