Custom Total Hip Arthroplasty with Image-Free Screw Removing Assisted by CT Based Navigation: A Case Report

Abstract

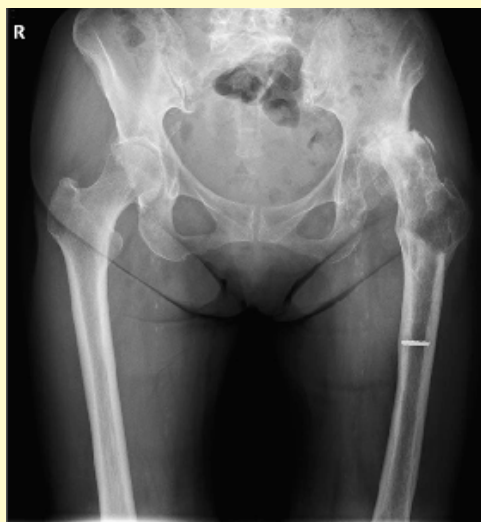
Figure 1: X-ray AP film before arthroplasty. Completely hidden screw was recognized in the femoral shaft.

77 years old female came to Nagoya City University Hospital with left coxalgia. She had Bombeli femoral Ottoman in 1989at another hospital. Implant removal was performed at another hospital several years after Osteotomy. With plain X-Ray films, a piece of broken screw was left in the femoral shaft (Figure 1). Moreover, it seemed that broken screw was completely covered with femoral cortical bone (Figure2). Due to this, left proximal femur had severe deformity by Osteotomy; we prepared custom made implant (JMM, Kyoto, Japan) and CT-based navigation system. Vector Vision Hip Ver.2.5.1 (Brain LAB, Munich, Germany) was applied as CT based Navigation system. The CT scans were obtained with SIEMENS SOATOM definition (Siemens, Erlangen, Germany), and the scanning protocol involved scanning of the lower lumbar spine to foot with 2 mm slice. Position of patients in the scanner was standardized with neutral abduction/adduction and with the patellae pointing directly upwards. The estimated total CTDI was 20 mGy.

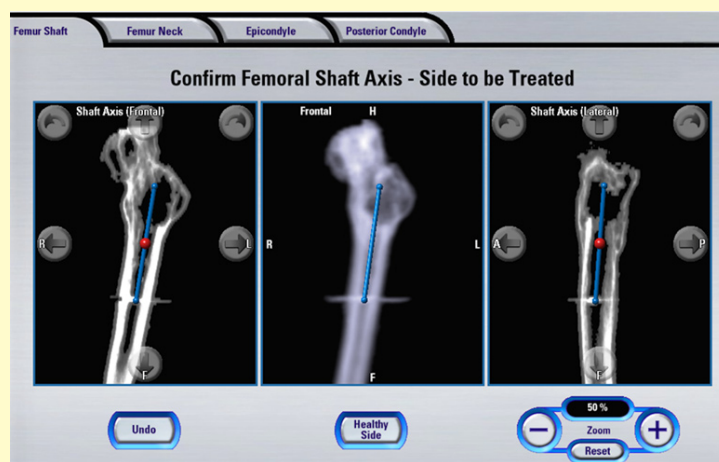
Figure 2: In MPR-CT scan on Vector vision Hip®, broken screw was seemed completely covered by cortical bone.

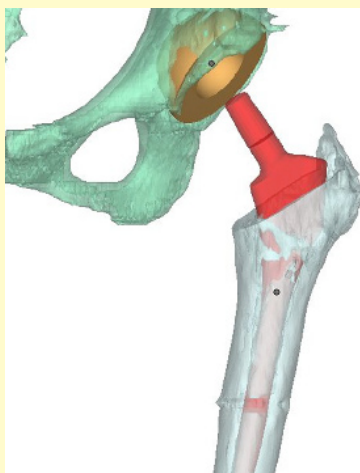
Figure 3: Hidden broken screw will disturb the custom stem insertion on 3D template.

The operation was done in 2009. Before the operation, 3D image was made with Magics® and Mimics® (Materialize Co Ltd, Belgium). The images showed the broken screw left in the bone interfering with stem insertion (Figure 3). Plain X-ray films and CT shows that the broken screw was hidden under cortical bone. The patient was in Lateral position during operation. Markers for navigation were set up on the pelvis and distal femoral (around 10cm proximal joint line). Posterior approach was performed. Registration was performed first. Calculated accuracy was 1.8 mm on registration of the CT based Navigation. It was below 1.9 mm that was recommended as verification of registration. To point out the hidden broken screw, the wound was extended to femoral side. We could accurately point out the hidden screw by the CT based Navigation (Figure 4). And the broken screw was easily removed from the screw removal, set (Synthes, Swiss) from a small drill hole made on femoral shaft (Figure 5). To prevent the fracture of the femoral shaft, commercial metal band (CCG

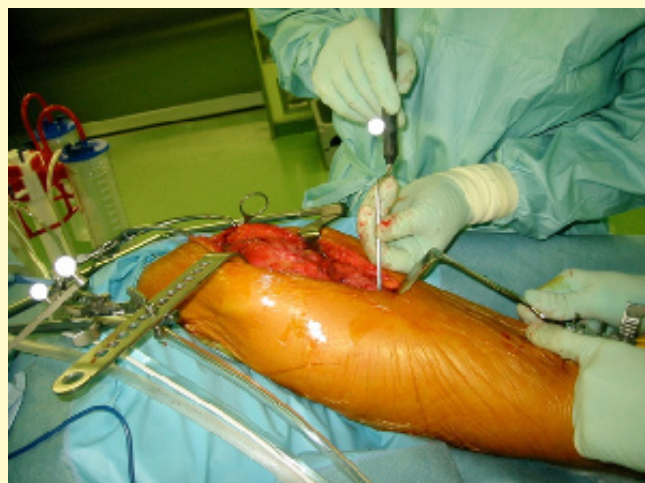
Figure 4A: Hidden screw seeking with pointer of Navigation System.

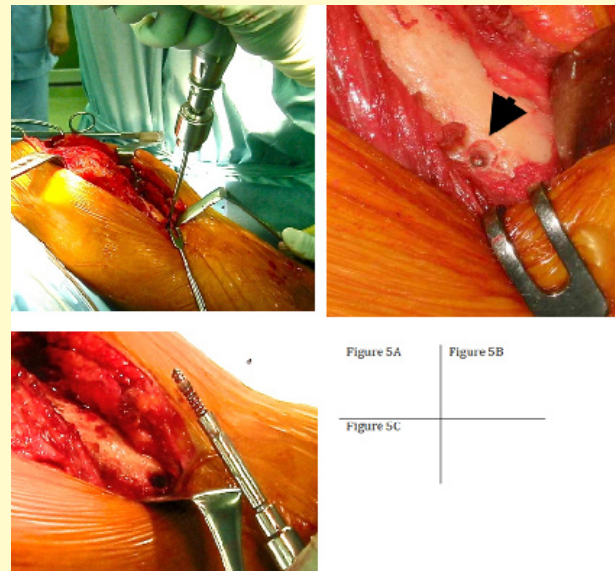
Figure 5A: Small drill hole was made on cortical bone at the position pointed out by CT-navigation.

Figure 5B: Broken screw was seen from small drill hole. (Black arrow)

Figure 5C: Safety removing hidden screw with screw removal kit.

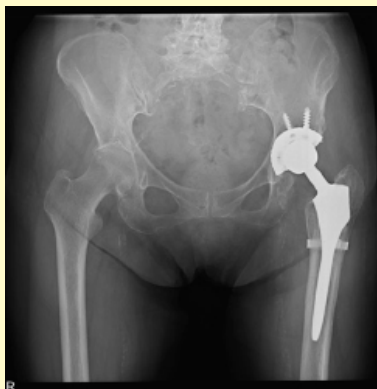
Figure 6: AP x-ray view after five years total hip arthroplasty.

band, Smith & Nephew, UK) was set on the femoral cortex at the inferior small trabecular. Total operating time was 128 min and the total blood loss was 814 ml. The patient started to walk on the next day of operation. After the arthroplasty there was no symptom with her left hip. After five years from primary total hip arthroplasty, there was no trouble with her hip (Figure 6).

This patient’s total hip implant condition was seen no subsidence and loosening. There were no major complications, for example, infection, periprosthetic fracture and so forth. The hidden screw removal with CT navigation will be a useful technique for navigation guided total hip or total knee arthroplasty.
