Long-term Course in a Patient with a Broken U-stabilizing Device in the Lumbar Spine

Objective: We report a case wherein a semi-rigid interspinous “U-stabilizing device” fixation system was used for lumbar spine fenestration, with breakage that occurred 19 years ago.

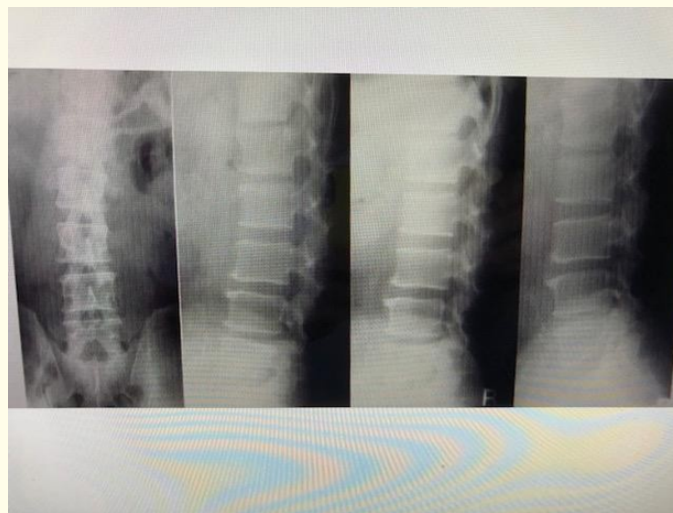
Figure 1: Pre-operative X-ray analysis for lumbar canal stenosis. From left to right: PA, flexion, neutral and extension views.

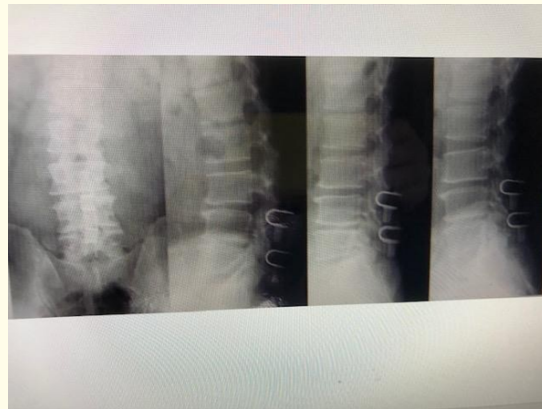
Figure 2: Post-operative X-ray analysis using U-device fixation. From left to right: PA, flexion, neutral and extension views.

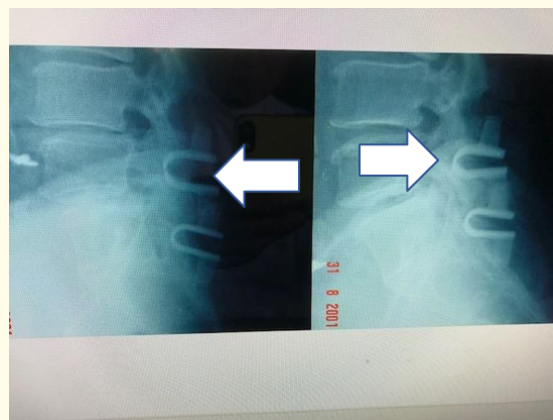
Figure 4: Breakage in the center of the U-device at the lumbar 3/4 vertebra: arrows. Left: flexion, right: extension functional views.

It is hard to be certain about the origin of the breakage, but it is probably due to a raw material failure. The X-rays seem to show a mobility of both parts of the device. Of course, there isn't any neurologic risk, because the total is stuck onto a fibrose avoiding any posterior migration, even less anterior, all the more because each part of the U-device is linked to the spine by the wings. So, if no pain is felt by the patient, I don't recommend to re-operate for the moment. Follow every year by X-rays. Of course, at the moment, the device doesn't fulfill its shock absorber function. We are in the case where the laminectomy has been done without posterior stabilization on this area. The only problem could be a potential metallosis around the breakage, but Magnetic Resonance Imaging would reveal it. As a conclusion, there is no risk in the future. I advise to do check-up X-rays, perhaps a Nuclear Magnetic Resonance, and not to re-operate the patient for the moment, as long as there isn't any symptom. (Original: French). Lyon, November 24, 2003 by Jacques Samani.

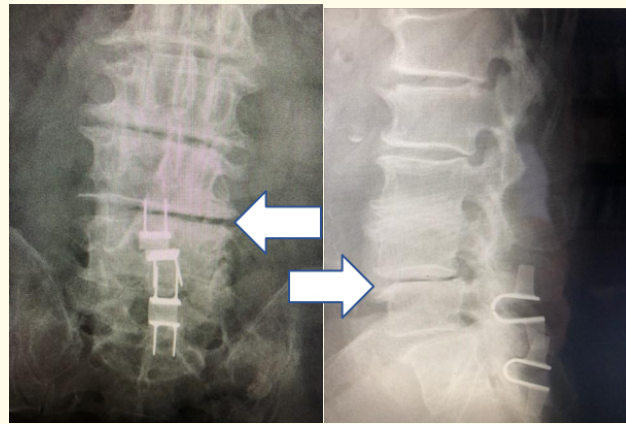
Subsequently, we examined the X-ray images over time. At 15 years after second surgery, a vacuum phenomenon in discs was observed at both intervertebral disc levels of L 3/4 and 4/5 for inter spinous process space narrowing strongly L 3/4 more than L 4/5 (Figure 5); however, there was no loosening in the spinous process to which the device was fixed and no deformation caused by broken U-device or effects on the dura mater tube due to metallosis and granulomatous fibrosis. Compare the shear stress inter vertebral body to spinous process reported 380 mega Pascal (MPa) versus 30 MPa by spine motion stabilization [3]. In 2022, the patient was able to perform activities of daily living as a retiree at 86 years of age (Figure 6). The functional imaging showed that the facet joint was maintained and no ankylosis or fracture was observed.

Figure 5: At 15 years after second surgery, a vacuum phenomenon was observed: arrows and broken U device at L3/4. Left: PA view and right: lateral neutral view.
