Esthetic Rehabilitation of a Discolored Maxillary Canine Tooth with a Porcelain Laminate Veneer

Case Report

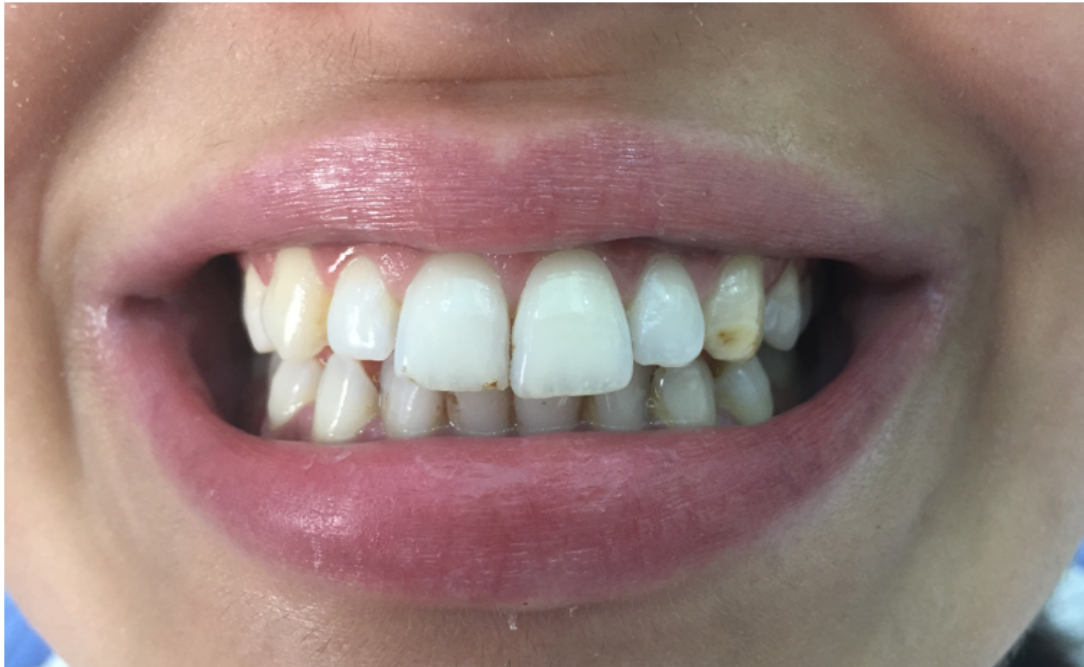
A 25-year-old female patient reported her discontent with a discoloration at her maxillary left canine tooth (Figure 1). On the clinical examination of the patient, fluorosis related discolorations were observed at the labial medium 2/3 and the incisal part of her left maxillary canine tooth. Radiographic and clinical examination did not reveal any caries or periapical pathological condition. Occlusion was in a class 1 relationship, oral hygiene was good and the gingival tissues were healthy. As a result of the examinations, all appropriate treatment options for this case were described to the patient. Cad/Cam manufactured and individualized by cut-back method porcelain laminate veneer was accepted by the patient as a treatment option.

Figure 1: Discolorations at left maxillary canine tooth.

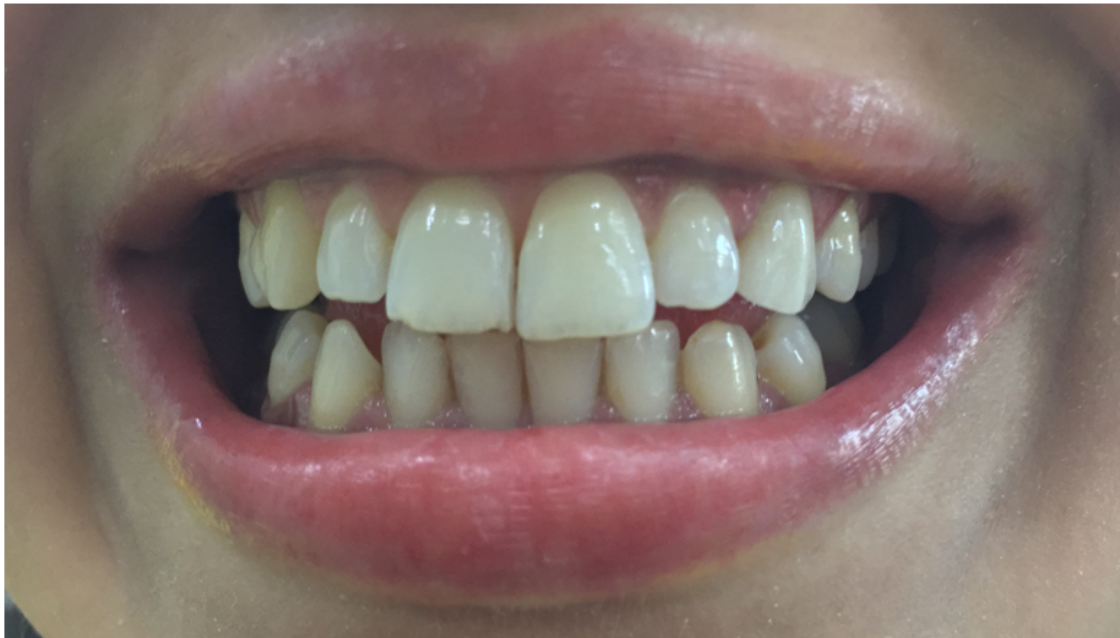
Figure 2: Clinical view after cementation process.

At the next clinical appointment tooth preparation was performed within minimally invasive approach followed by the final shade selection by utilizing a chromascop shade guide (Vita Toothguide 3D-Master; Vita, Zahnfabrik, Bad Sackingen, Germany). Final impressions were made using a polyvinyl-siloxane impression material (Elite-HD, Zhermack, Badia Polesine, Italy) by Putty-Wash technique. Temporary restoration was prepared with a self-curing composite material (Structur Premium, A2, VOCO, Cuxhaven, Germany) and cemented on the tooth surface by applying single point bonding technique (Single Bond, 3M ESPE, St Paul MN, USA).

Porcelain laminate veneer was manufactured by Cad/Cam method (Sirona X5 Scanner - Sirona Inlab 3D Software - Sirona MCX5 Milling Machine, Sirona Dental Systems, Germany; Vitablocs Triluxe Color 1M2, Vita Zahnfabrik, Bad Sackingen, Germany). Individualizations were made in cut-back technique to achieve the proper esthetic result (Vita VM 9 Porcelain, Vita Zahnfabrik, Bad Sackingen, Germany). The coherence and the fit of the laminate veneer were verified both individually and collectively on the prepared tooth. The patient was satisfied with the form, shade and adaptation of the restoration. Final cementation was done with a dual-cure resin cement (Variolink Esthetic Neutral, Ivoclar-Vivadent, Schaan, Lichtenstein) (Figure 2). The occlusion and contact correction with final polishing and finishing process was applied after 24 hours of cementation. Post-operative photos were taken and a night guard oral appliance was performed in order to prevent any trauma on the veneer caused by the parafunctional habits (Figure 3). One year post-operative evaluation did not reveal any fracture or discoloration of the veneer restoration (Figure 4). Patient was pleased with the conformity and esthetics of the restoration.

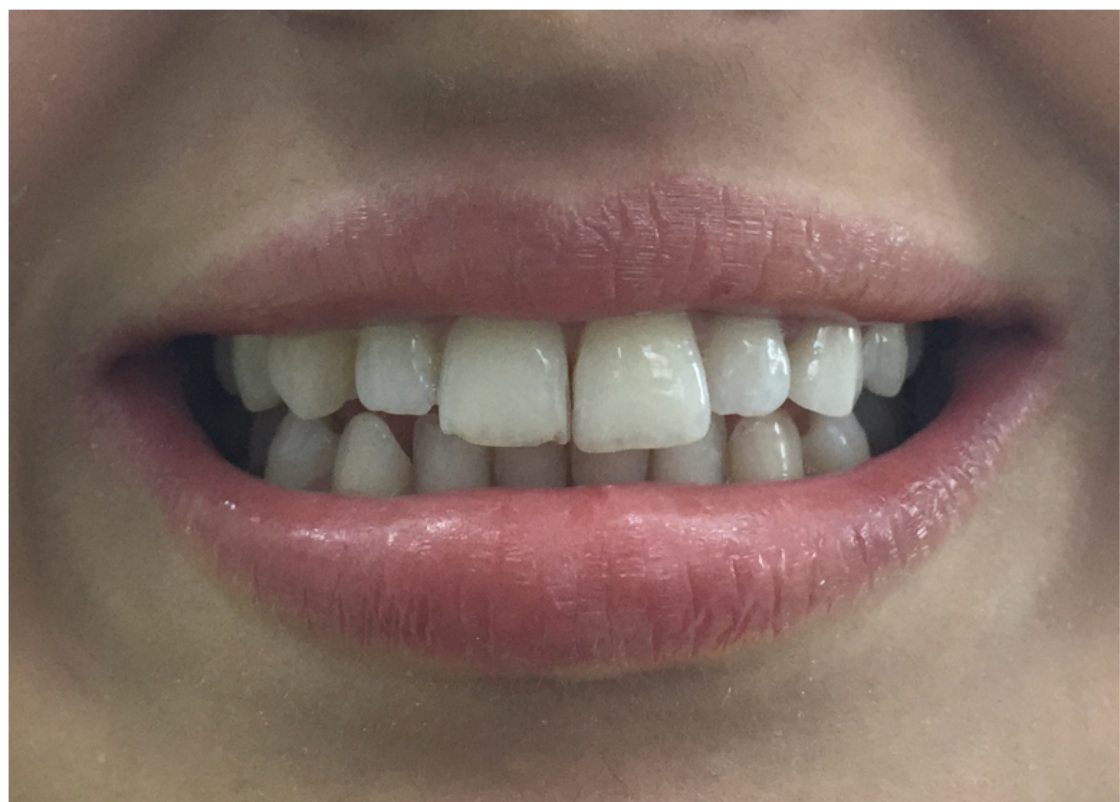
Figure 3: The occlusion and contact correction with final polishing and finishing process was applied after 24 hours of cementation.

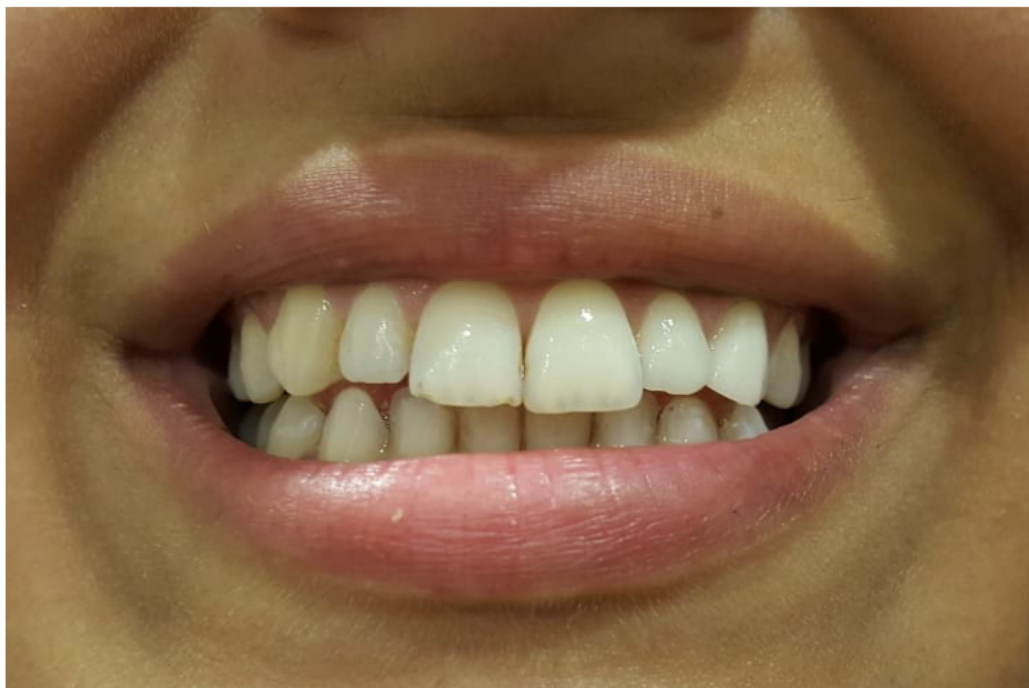
Figure 4: One year post-operative view.
