Management of Dental Erosion with Dahl Technique

Aims: This report aims at presenting the diagnosis and management of patient with localized tooth wear in anterior teeth using Dahl technique.

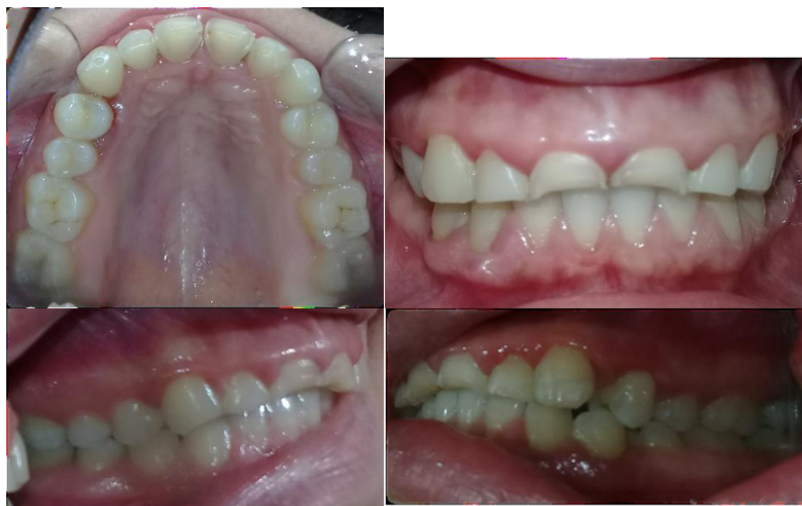
Clinical examination: The patient was presented with normal TMJ, and class I incisor relation; the oral examination revealed severe wear of hard dental tissue in the maxillary anterior teeth involving the palatal and incisal edge, yellowing of the teeth as the underlying dentin was exposed, shortening of the clinical crown height; the (OVD) was maintained but there was a reduction in the inter-occlusal space and this lead to treatment difficulties unless space is created (Figure 1).

Figure 1: Pre-operative.

Diagnosis and treatment: According to the history and the clinical findings, the diagnosis was erosion on the maxillary anterior teeth caused by eating citrus fruit.

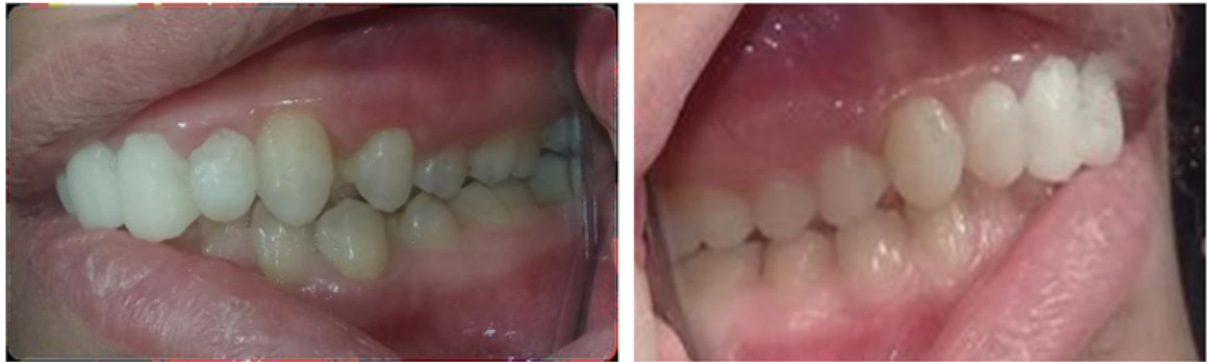
Figure 2: Free hand technique.

The worn teeth were built using a free hand technique. Initially, the canines were built with composite which is to control the occlusion. Before the curing, the mandible was manipulated to close into the centric occlusion. When the desired anterior space was obtained, the composite was cured and the process was repeated for the central and lateral incisors. The restoration was trimmed and finished with fine diamonds [10] (Figure 2).

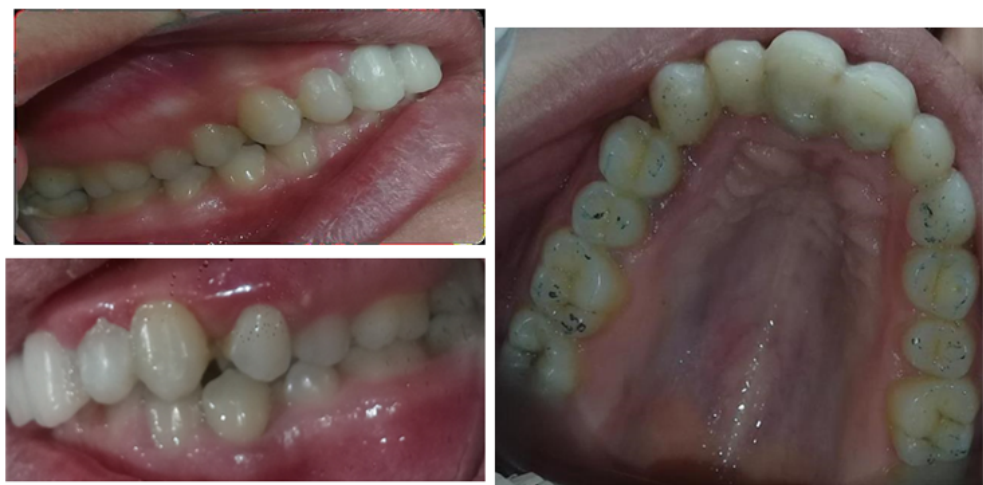
Figure 3

The occlusion was re-established over a period of three months and the opposite posterior teeth were in contact (Figure 3).

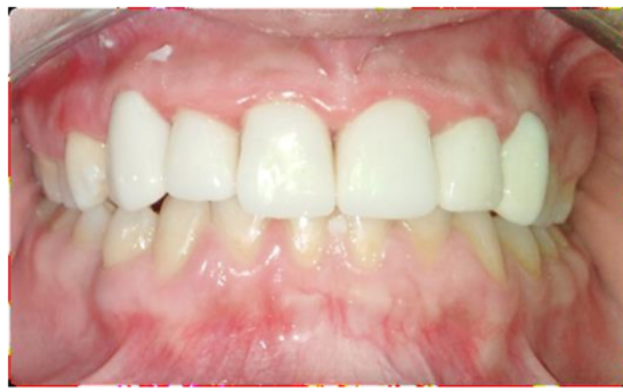
Figure 4: Final restoration.

Finally, the maxillary anterior teeth were prepared for full ceramic restorations; an impression was made with polyvinyl siloxane impression material using the stock tray, and an interocclusal record was taken. Then, the zirconia crowns were cemented into the prepared teeth with a glass ionomer cement (Figure 4).
